JOINT INVESTIGATION REPORT

INCIDENT NO: 2402662 JIV report S/N: 1030045

1. Fountain Incident Number: 2402662 2. Type of incident* OIL SPILL
3. Name of Location 14" OKORDIA - RUMMEKPE PIPELINE
4. Name of nearest community IKARAMA 5. State: BAYELSA LGA TENAGOA
7. Type of Production facility/Installation OIL PIPELINE
8. Asset owner/District THE SHELL PETROLEUM DEVELOPMENT COMPANY OF NIGERIA LIMITED / PIPELINE

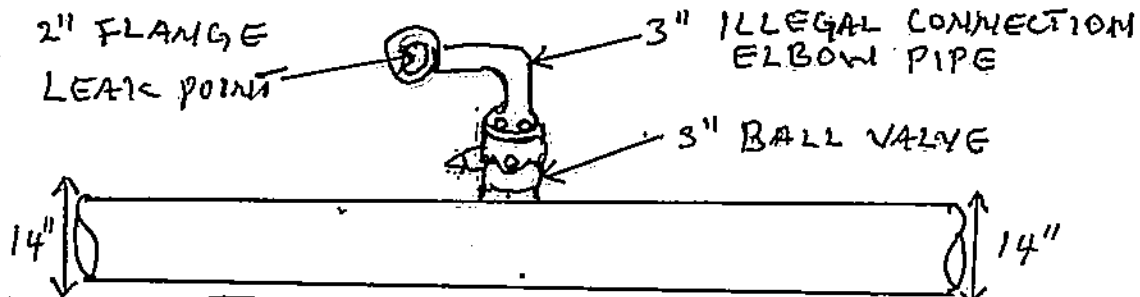
SECTION OF 14" OKORDIA - RUMUKEPE PIPELINE AT IKARAWA SHOWING CRUDE OIL THEFT POINT INSTALLED AT 12 O'CLOCK POSITION.

FROM OKORDIA TO RUMUKEPE
