# JOINT INVESTIGATION REPORT

INCIDENT NO: 2394852 JIV report S/N: 1030006

1. Fountain Incident Number: 2394852 2. Type of incident\* OIL SPILL  
3. Name of Location: 12" IMO RIVER - OGALE PIPELINE  
4. Name of nearest community: OGALE 5. State: RIVERS 6. LGA: ELEME  
7. Type of Production facility/Installation: OIL PIPELINE  
8. Asset owner/District: THE SHELL PETROLEUM DEVELOPMENT COMPANY OF NIGERIA LTD (SPDC) / PIPELINE

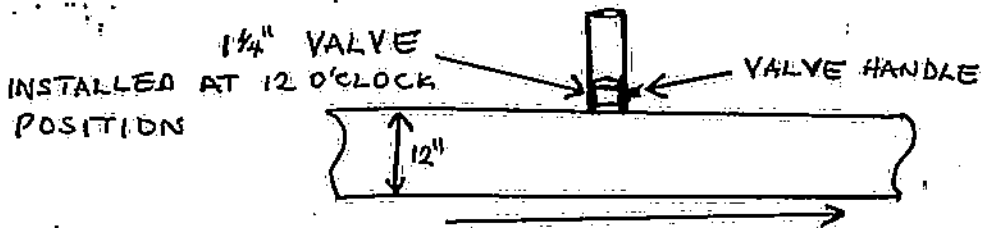
E. GRAPHIC DESCRIPTION OF LEAK POINT (while detail report of the leak point should be contained in the leak report, overview sketch of the site should be added as an appendix 1) A SECTION OF 12" IMO RIVER - OGALE PIPELINE AT OGALE SHOWING 1 1/4" CRUDE THEFT VALVE INSTALLED AT 12 O'CLOCK POSITION BY UNKNOWN PERSONS

IMO RIVER TO OGALE

REPAIR BY CLAMPING
