JOINT INVESTIGATION REPORT

INCIDENT NO: 2402883 JIV report S/N: 1030030

1. Fountain Incident Number: 2402883 2. Type of incident* OIL SPILL
3. Name of Location 24" BOMU - BONNY PIPELINE
4. Name of nearest community OWOKIRI 5. State: RIVERS 6. LGA ANDONI
7. Type of Production facility/Installation OIL PIPELINE
8. Asset owner/District THE SHELL PETROLEUM DEVELOPMENT COMPANY OF NIGERIA LTD (SPDC) / PIPELINE

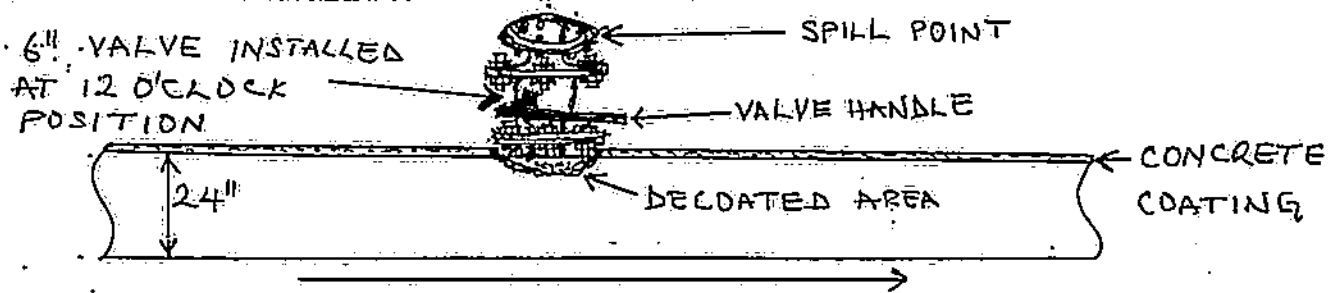
| <input checked="" type="checkbox"/> Crude oil theft (illegal bunkering) point, | <input type="checkbox"/> Saver-pit over flow | <input type="checkbox"/> Third party tampering with Clamp |

E. GRAPHIC DESCRIPTION OF LEAK POINT (while detail report of the leak point should be contained in the leak report, overview sketch of the site should be added as an appendix I) A SECTION OF 24" BOMU - BONNY PIPELINE AT OWDKIRI SHOWING 6" VALVE CRUDE OIL THEFT POINT INSTALLED AT 12 O'CLOCK POSITION BY UNKNOWN PERSON

REPAIR BY CLAMPING
