JOINT INVESTIGATION REPORT

INCIDENT NO: 2405103 JIV report S/N: 1030050

1. Fountain Incident Number: 2405103 2. Type of incident* OIL SPILL
3. Name of Location 20" KOLDCREEK - RUMUEKPE PIPELINE
4. Name of nearest community OKOMA 5. State: RIVERS 6. LGA AHOADA EAST
7. Type of Production facility/Installation OIL PIPELINE
8. Asset owner/District THE SHELL PETROLEUM DEVELOPMENT COMPANY OF NIGERIA LTD (SPDC) / PIPELINE

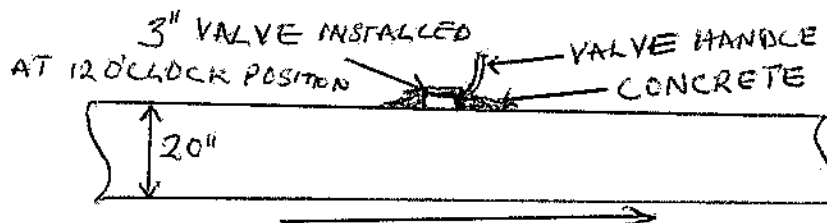
E. GRAPHIC DESCRIPTION OF LEAK POINT (while detail report of the leak point should be contained in the leak report, overview sketch of the site should be added as an appendix 1)

| <input checked="" type="checkbox"/> Crude oil theft (illegal bunkering) point, | <input type="checkbox"/> Saver-pit over flow | <input type="checkbox"/> Third party tampering with Clamp |

A SECTION OF 20" KOLOCREEK - RUMUEKPE PIPELINE AT OKOMA SHOWING A 3" VALVE CRUDE THEFT POINT INSTALLED AT 12 O'CLOCK POSITION BY UNKNOWN PERSONS.

KOLOCREEK TO RUMUEKPE

REPAIR BY CLAMPING
