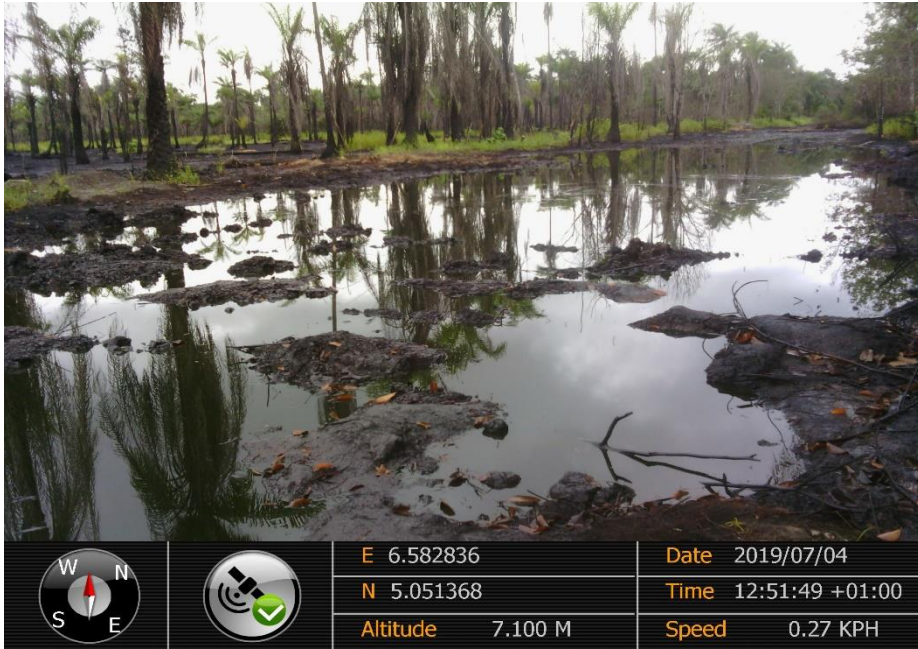
**Overview:** Part of spill impact on 14" Okordia - Rumuekpe Pipeline Right of Way at Ula-Ikata. Picture was taken during Joint Investigation of 4<sup>th</sup> July 2019.

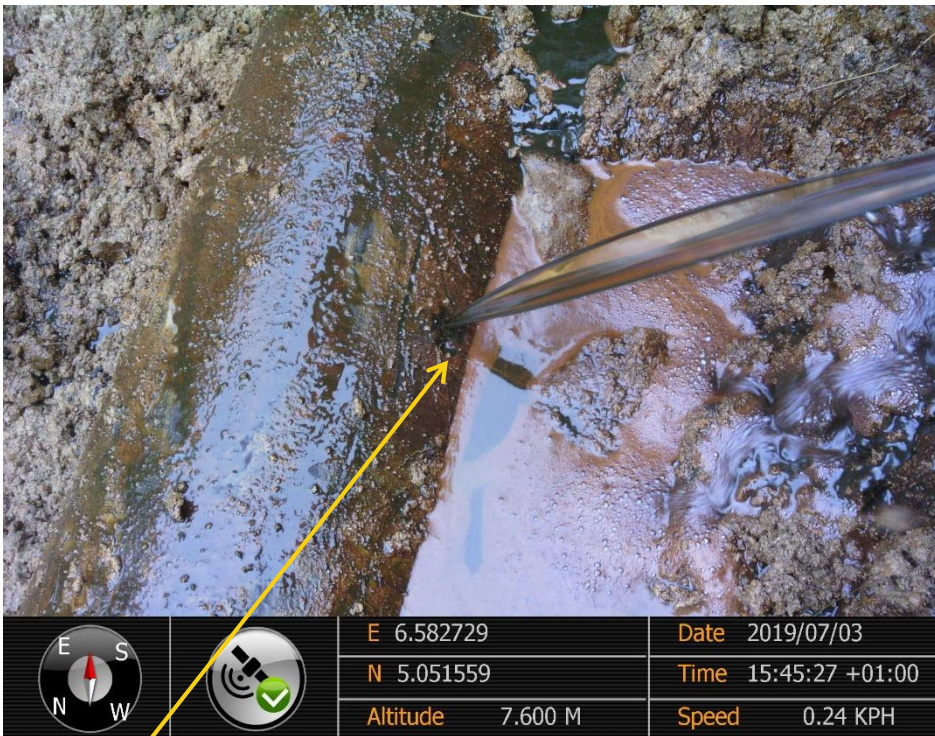
**Close-up:** Drilled Hole on 14" Okordia - Rumuekpe Pipeline at Ula-Ikata. Picture was taken during Joint Investigation of 3<sup>rd</sup> July 2019

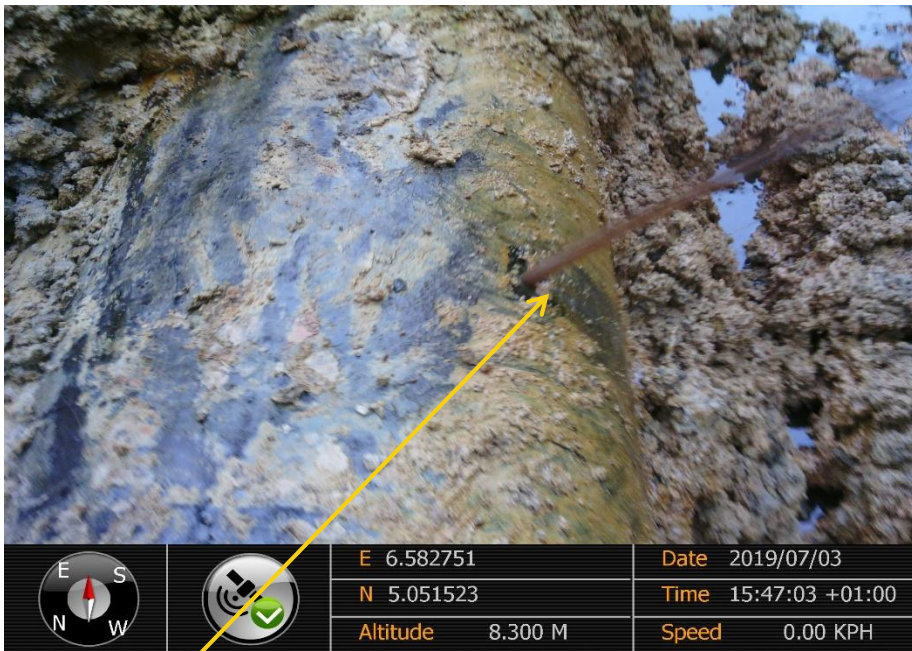
Close-up: Drilled Hole on 14" Okordia-Rumuekpe Pipeline at Ula-Ikata. Picture was taken during Joint Investigation of 3<sup>rd</sup> July 2019

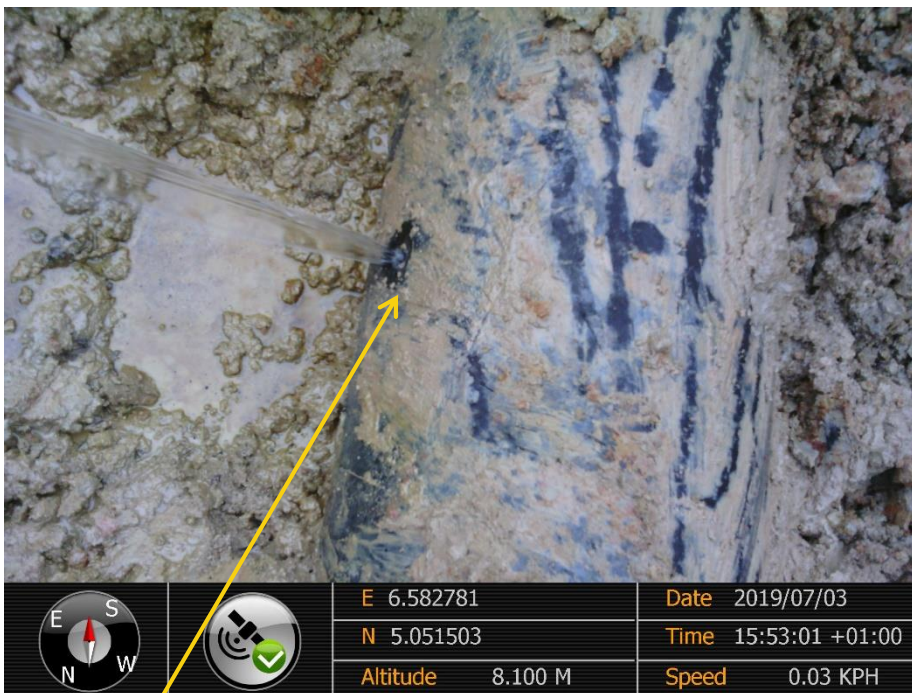
Close-up: Drilled Hole on 14" Okordia - Rumuekpe Pipeline at Ula-Ikata. Picture was taken during Joint Investigation of 3<sup>rd</sup> July 2019
