# JOINT INVESTIGATION REPORT

INCIDENT NO: 2365292 JIV report S/N: 1030009

1. Fountain Incident Number: 2365292 2. Type of incident\* OIL SPILL  
3. Name of Location 36" NKPOKU - OGALE PIPELINE  
4. Name of nearest community RUMUESARA 5. State: RIVERS 6. LGA OBIO-AKPO  
7. Type of Production facility/Installation OIL PIPELINE  
8. Asset owner/District THE SHELL PETROLEUM DEVELOPMENT COMPANY OF NIGERIA LIMITED / PIPELINE

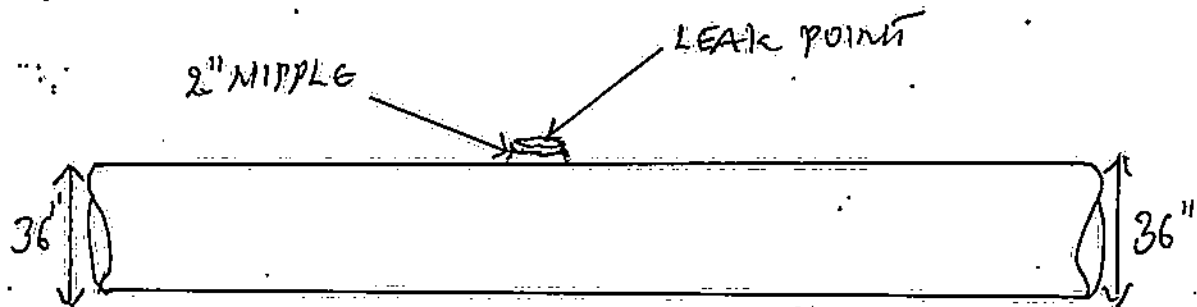
Additional observations around the spill point: SANDBAGS CONCEALING CRUDE OIL THEFT POINT WAS OBSERVED BY THE JOINT INVESTIGATION TEAM.

| <input checked="" type="checkbox"/> Failed Weld on illegal hot tap valve | <input type="checkbox"/> Failed Clamp, | <input type="checkbox"/> Missing Pipeline/Flowline |
| <input checked="" type="checkbox"/> Crude oil theft (illegal bunkering) point, | <input type="checkbox"/> Saver-pit over flow | <input type="checkbox"/> Third party tampering with Clamp |

SECTION OF 36" NKPOKU - OGALE PIPELINE AT RUMUESHARA (ENKRA) SHOWING CRUDE OIL THEFT POINT AT 12 O'CLOCK POSITION.

FROM NKPOKU TO OGALE
