JOINT INVESTIGATION REPORT

INCIDENT NO: 2365335 JIV report S/N: 1030010

1. Fountain Incident Number: 2365335 2. Type of incident* OIL SPILL
3. Name of Location 8" NKALI - IMORIVER 2 PIPELINE
4. Name of nearest community ODAGNIA 5. State: RIVERS S. LGA ETCHE
7. Type of Production facility/Installation OIL PIPELINE
8. Asset owner/District THE SHELL PETROLEUM DEVELOPMENT COMPANY OF NIGERIA LIMITED / PIPELINE

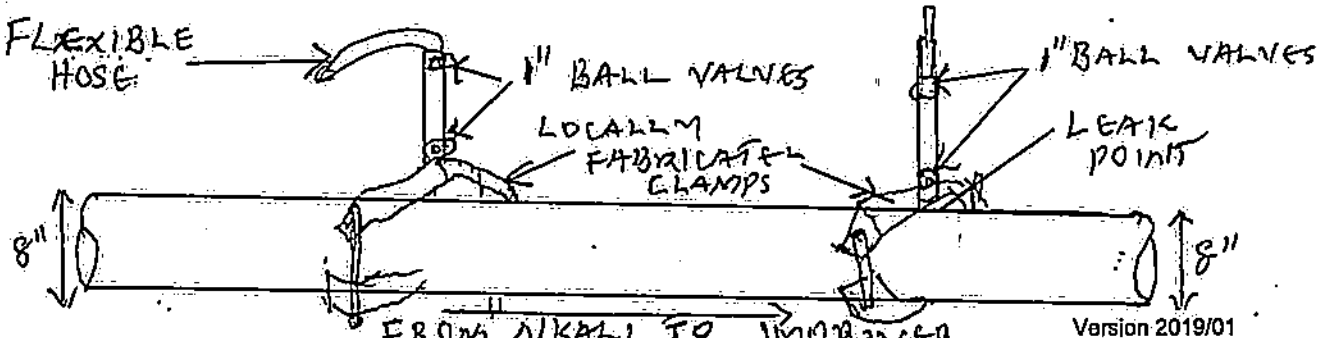
E. GRAPHIC DESCRIPTION OF LEAK POINT (while detail report of the leak point should be contained in the leak report, overview sketch of the site should be added as an appendix 1)

| <input checked="" type="checkbox"/> Failed Weld-on illegal hot tap valve | <input type="checkbox"/> Failed Clamp, | <input type="checkbox"/> Missing Pipeline/Flowline |
| <input checked="" type="checkbox"/> Crude oil theft (illegal bunkering) point, | <input type="checkbox"/> Saver-pit over flow | <input type="checkbox"/> Third party tampering with Clamp |

SECTION OF 8" NIKALI - IMORIVER 2 PIPELINE AS ODAGINA SHOWING TWO NOS OF CRUDE OIL THEFT POINTS AT 12 O'CLOCK POSITION.

REPAIR WAS DONE BY CLAMPING.
