# JOINT INVESTIGATION REPORT

INCIDENT NO: 2370608 JIV report S/N: 1030016

1. Fountain Incident Number: 2370608 2. Type of incident\* OIL SPILL  
3. Name of Location 14" OKORDIA - RUMUEKPE PIPELINE  
4. Name of nearest community AKARA - OLU 5. State: RIVERS 6. LGA AHOADA WEST  
7. Type of Production facility/Installation OIL PIPELINE  
8. Asset owner/District THE SHELL PETROLEUM DEVELOPMENT COMPANY OF NIGERIA LIMITED/PIPELINE

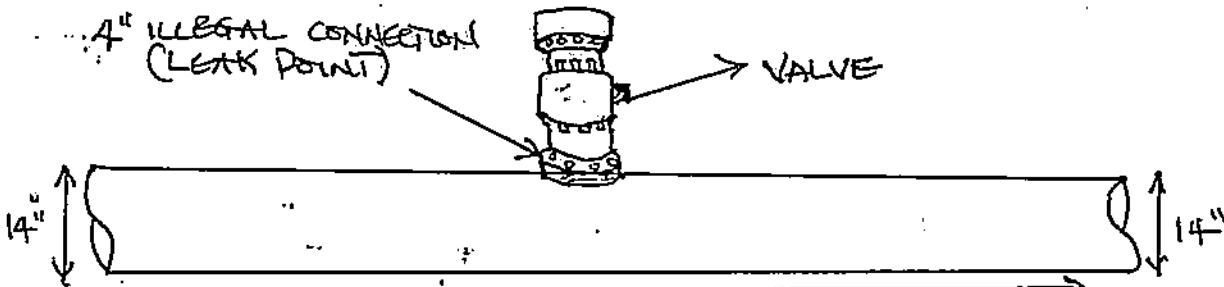
**E. GRAPHIC DESCRIPTION OF LEAK POINT** (while detail report of the leak point should be contained in the leak report, overview sketch of the site should be added as an appendix 1) **A SECTION OF 14" OKORDIA - RUMUEKPE PIPELINE SHOWING 4" ILLEGAL CONNECTION INSTALLED AT 12 O' CLOCK POSITION BY UNKNOWN PERSONS**

REPAIR BY CLAMPING ONGOING.
