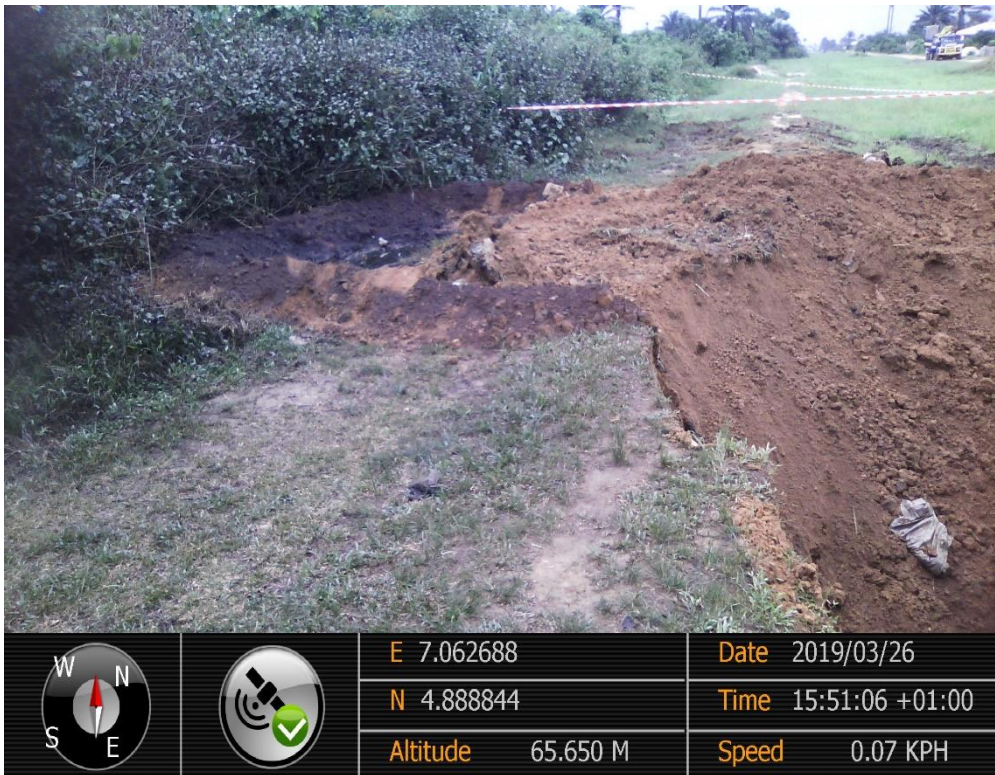
**Overview:** Part of spill impact on 36'' Nkpoku - Bomu Pipeline Right of Way at Atali. Picture was taken during Joint Investigation of 26<sup>th</sup> March 2019.

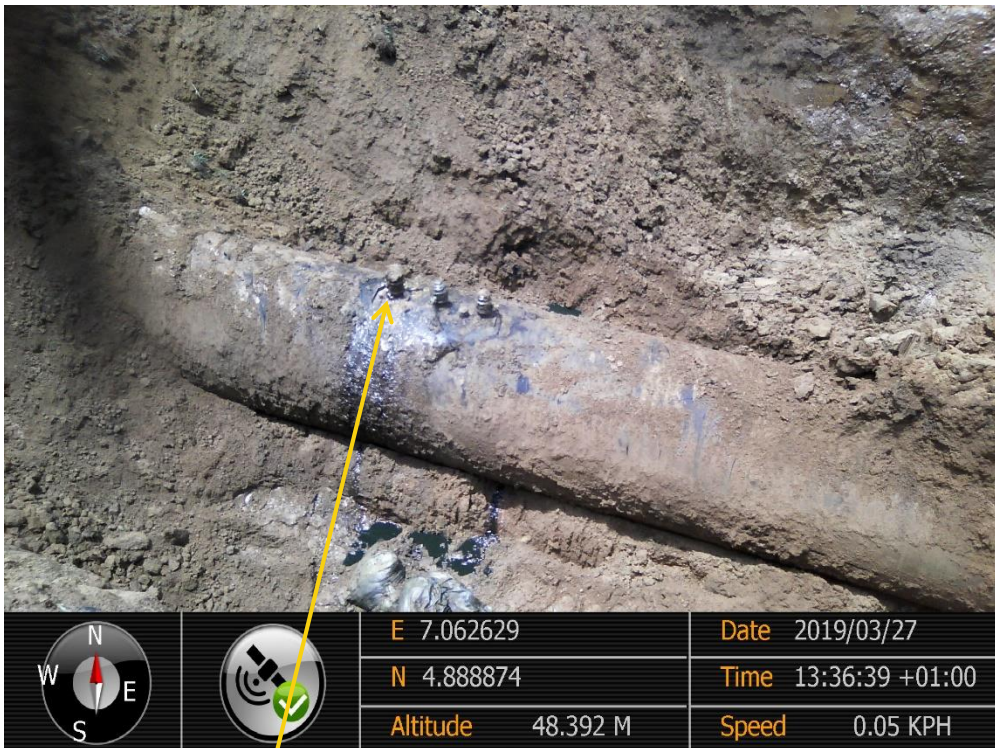
**Close-up:** Leaking Illegal fitting on 36'' Nkpoku - Bomu Pipeline at Atali. Picture was taken during Joint Investigation of 27<sup>th</sup> March 2019
