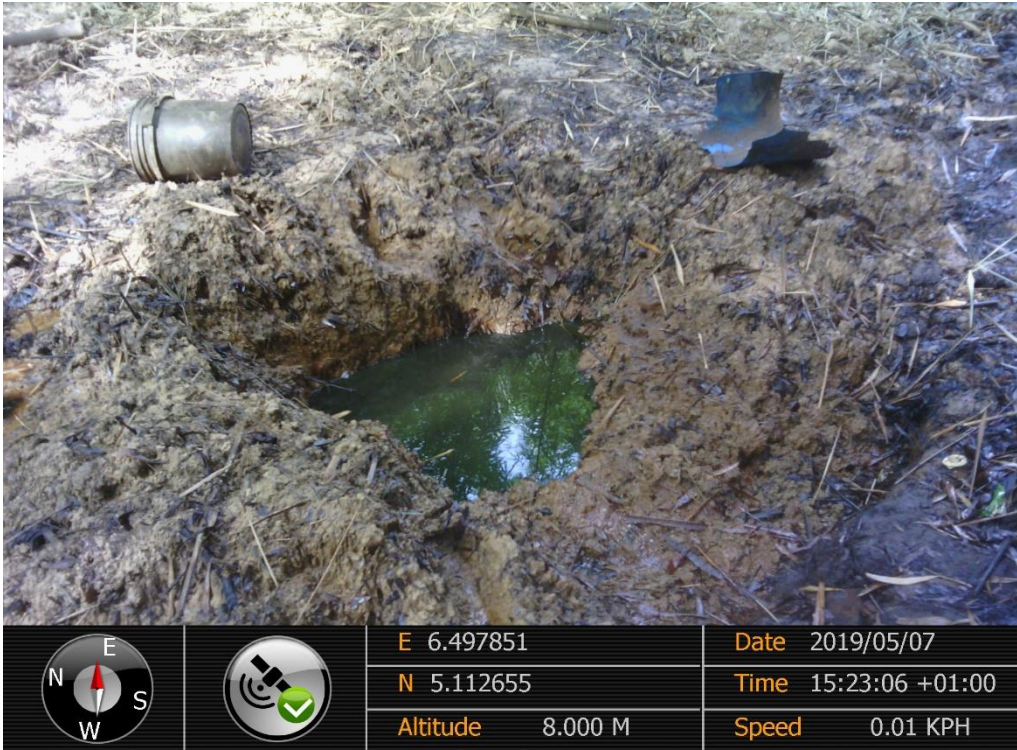
Overview: Part of spill impact on 14" Okordia - Rumuekpe Pipeline Right of Way at Akala-Olu. Picture was taken during Joint Investigation of 7th May 2019.

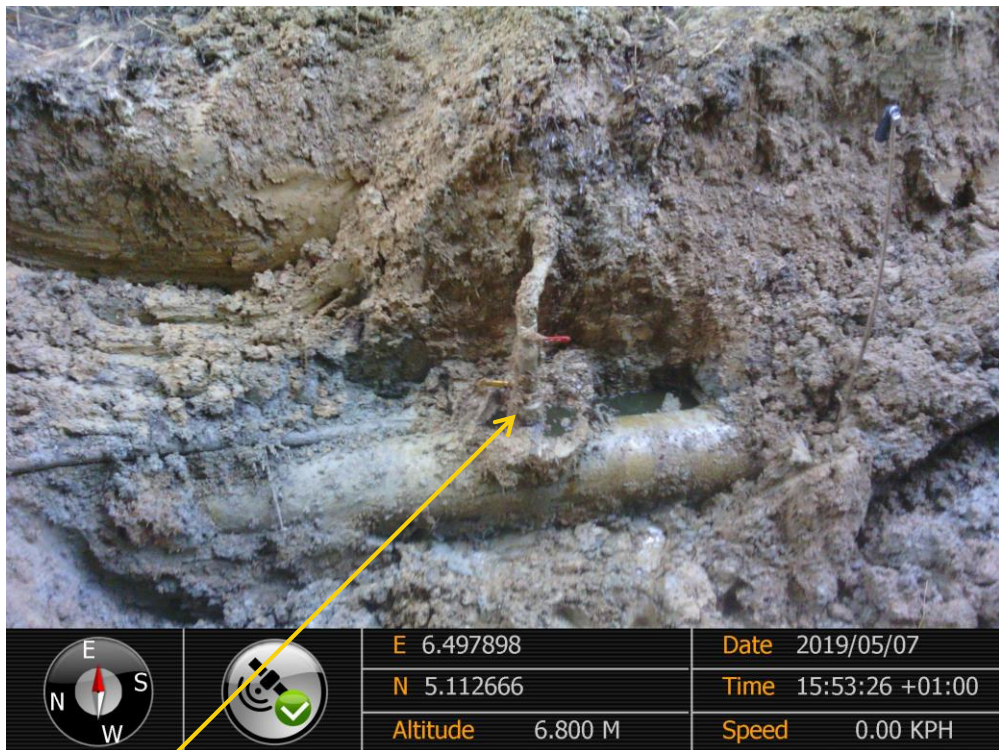
Close-up: Illegal fitting on 14" Okordia - Rumuekpe Pipeline at Akala-Olu. Picture was taken during Joint Investigation of 7th May 2019
