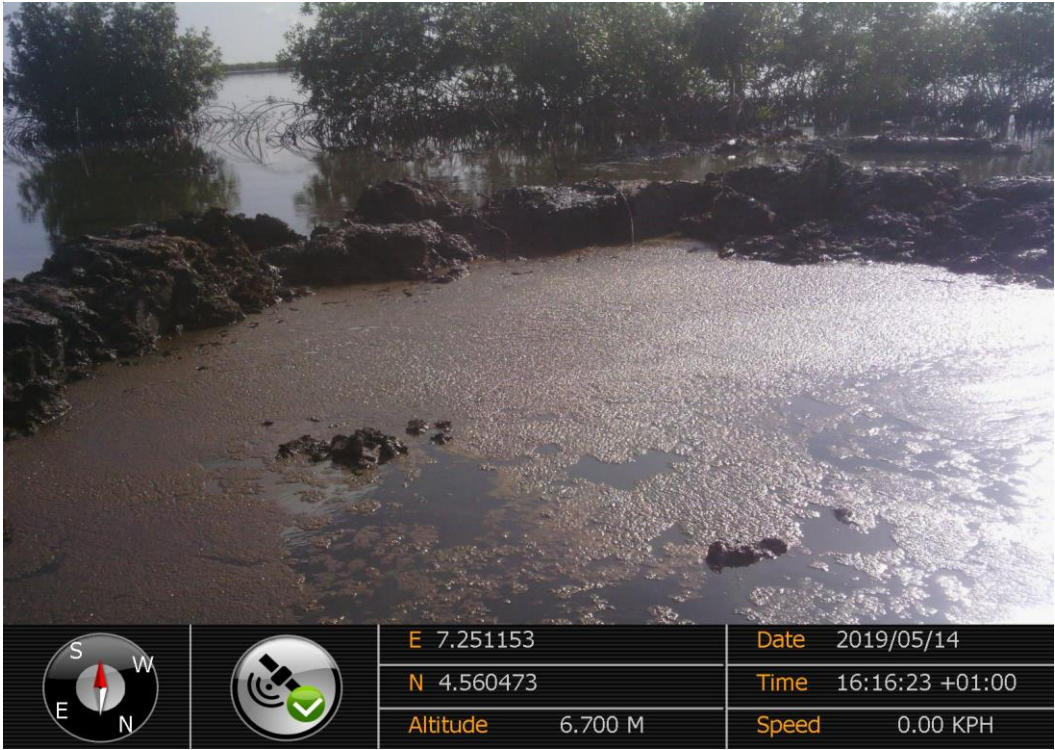
**Overview:** Part of spill impact on 28" Bomu – Bonny Pipeline Right of Way at Owokiri. Picture was taken during Joint Investigation of 14<sup>th</sup> May 2019.

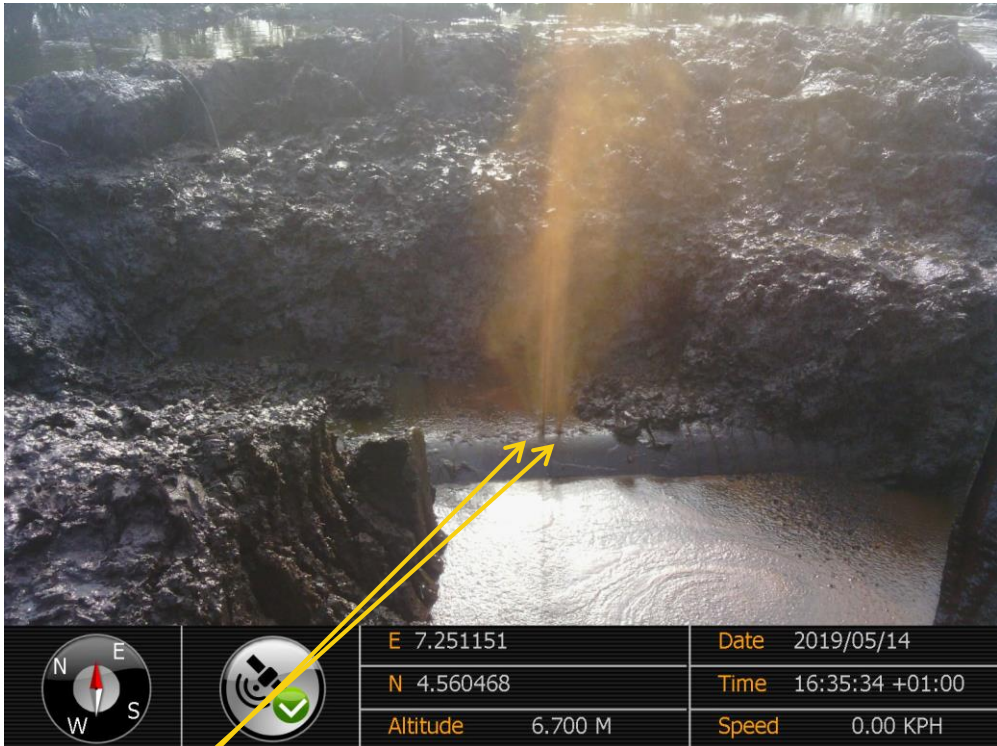
**Close-up:** Hack Saw Cuts on 28" Bomu – Bonny Pipeline at Owokiri. Picture was taken during Joint Investigation of 14<sup>th</sup> May 2019
