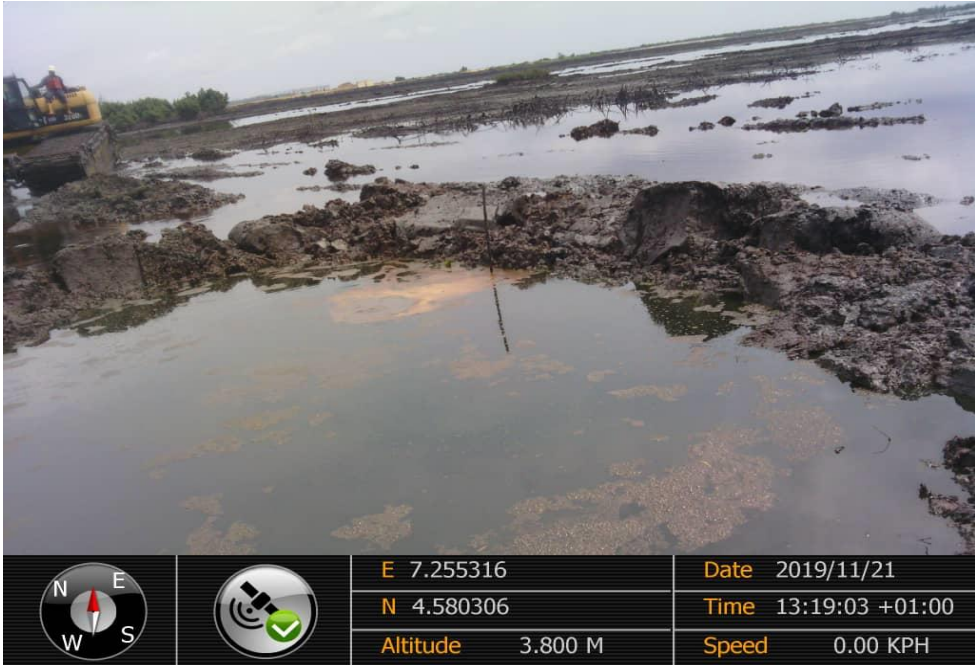
Overview: Part of spill impact on 28" Bomu – Bonny Pipeline Right of Way at Patrick Waterside - Bodo West . Picture was taken during Joint Investigation of 21st November 2019.

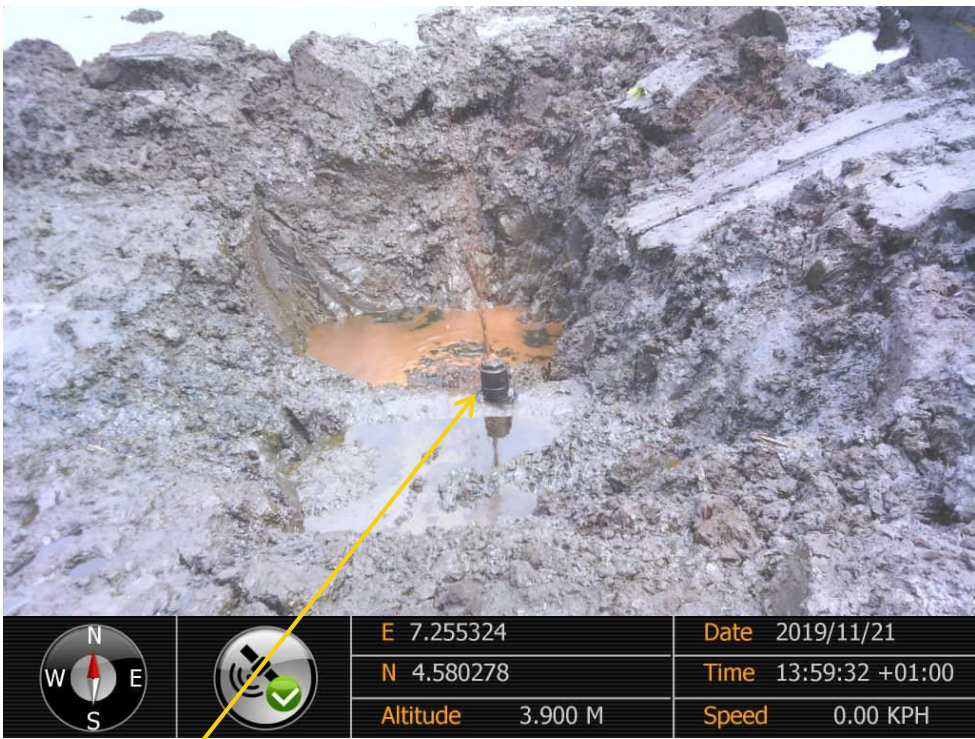
Close-up: Illegal fitting on 28" Bomu – Bonny Pipeline at Patrick Waterside - Bodo West . Picture was taken during Joint Investigation of 21st November 2019.
