JOINT INVESTIGATION REPORT

INCIDENT NO: 2517119 JIV report S/N: 1030204

1. Fountain Incident Number: 2517119 2. Type of incident: OIL SPILL
3. Name of Location: 12" MORNER 2 - OGALE
4. Name of nearest community: ODAGWA 5. State: RIVERS 6. LGA: ETCHE
7. Type of Production facility/Installation: OIL PIPELINE
8. Asset owner/District: THE SHELL PETROLEUM DEVELOPMENT COMPANY OF NIGERIA LIMITED (SPDC) / PIPELINE

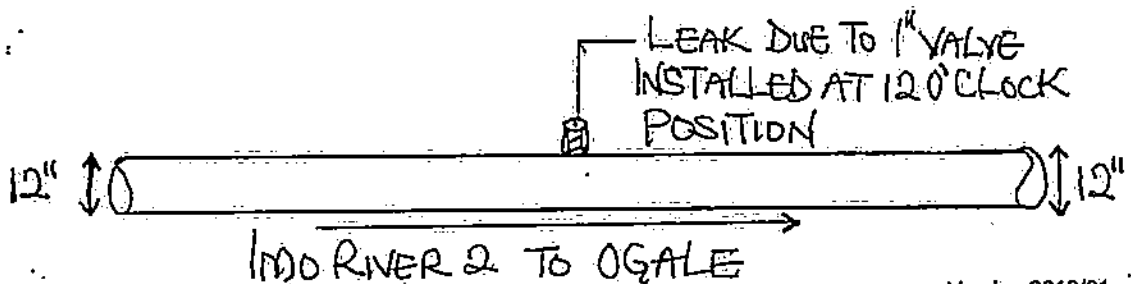
E. GRAPHIC DESCRIPTION OF LEAK POINT (while detail report of the leak point should be contained in the leak report, overview sketch of the site should be added as an appendix 1) A SECTION OF 12" MO RIVER 2- OGALE PIPELINE AT ODAGWA SHOWING INSTALLED AT 12 O'CLOCK POSITION BY UNKNOWN(S).

CLAMPING IN PROGRESS / RECOVERY AND EVACUATION
