JOINT INVESTIGATION REPORT

INCIDENT NO: 2514205 JIV report S/N: 1030211

1. Fountain Incident Number: 2514205 2. Type of incident* OIL SHEEN AROUND NON-LEAKING ILLEGAL CONNECTION
3. Name of Location 20" OPUKUSHI - BRASS CREEK PIPELINE
4. Name of nearest community TAMOGBENE 5. State: BAYELSA 6. LGA EKEREMOR
7. Type of Production facility/Installation PIPELINE
8. Asset owner/District SHELL PETROLEUM DEVELOPMENT COMPANY / PIPELINE

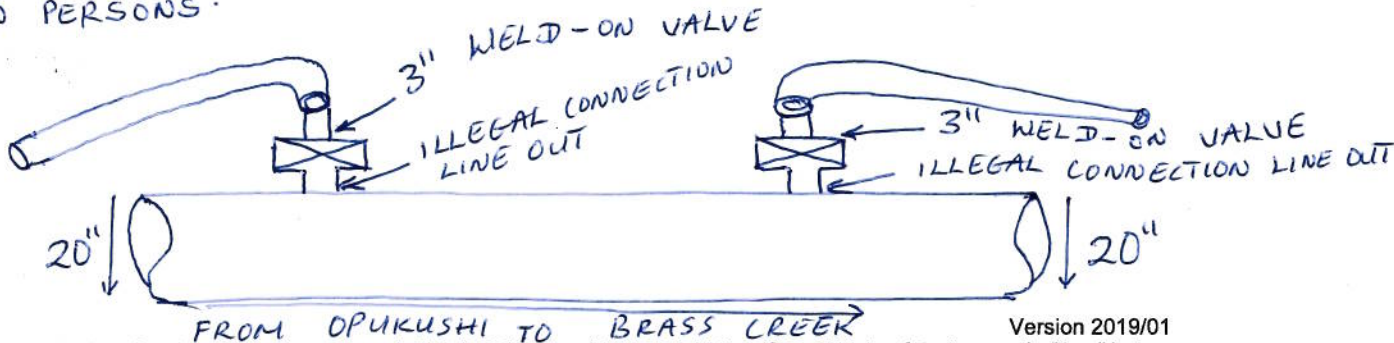
A SECTION OF 20" OPUKUSHI - BRASS CREEK PIPELINE AT TAMOGBENE SHOWING TWO (2) NO'S OF WELD-ON 3" VALVE INSTALLED AT 12 O'CLOCK POSITION BY UNKNOWN PERSONS.
