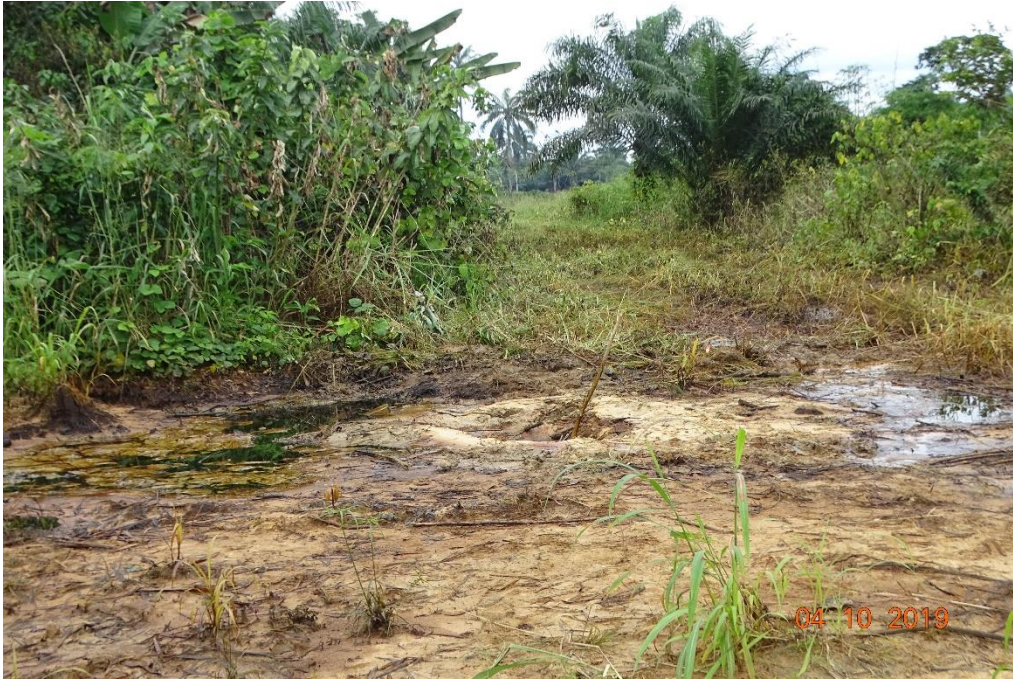
Overview: Part of spill impact on 14" Okordia - Rumuekpe Pipeline Right of Way at Ikata. Picture was taken during Joint Investigation of 4<sup>th</sup> October 2019.

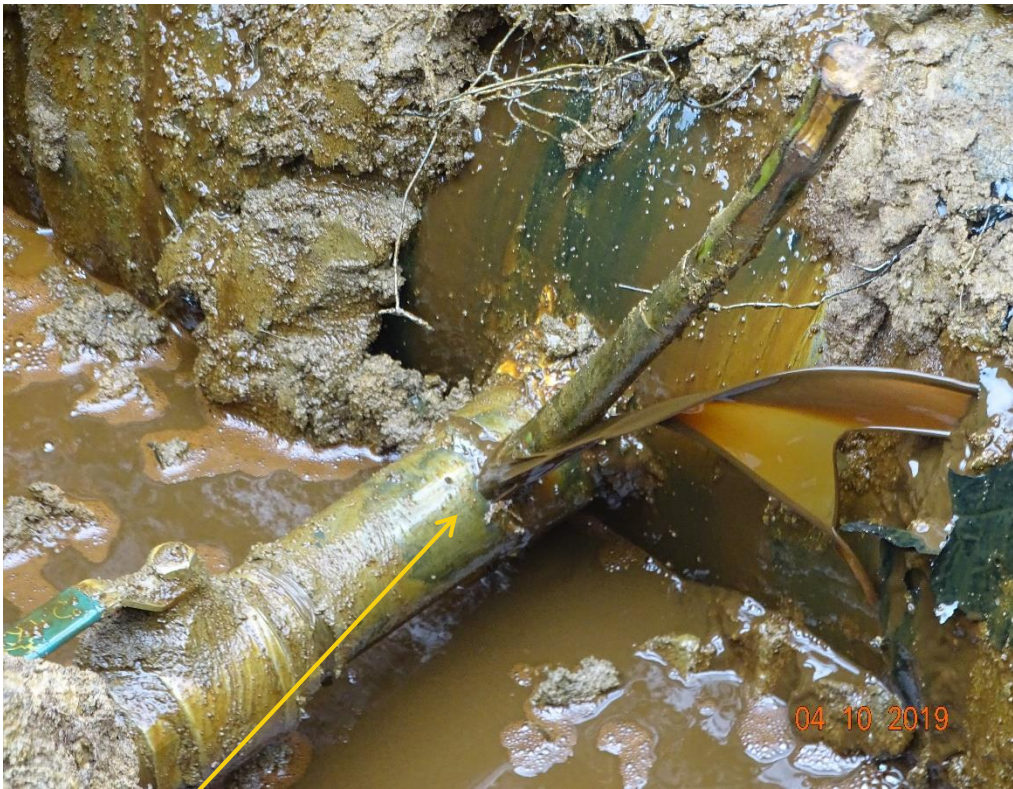
Close-up: Illegal fitting on 14" Okordia - Rumuekpe Pipeline at Ikata. Picture was taken during Joint Investigation of 4<sup>th</sup> October 2019.
