JOINT INVESTIGATION REPORT

INCIDENT NO: 2482496 JIV report S/N: 1030135

1. Fountain Incident Number: 2482496 2. Type of incident* OIL SPILL
3. Name of Location AGBADAI WELL 6th FLOWLINE
4. Name of nearest community DMUEKE 5. State: RIVERS 6. LGA IKWERRE
7. Type of Production facility/Installation FLOWLINE
8. Asset owner/District THE SHELL PETROLEUM DEVELOPMENT COMPANY OF NIGERIA LIMITED (SPDC) / LAND EAST HUB

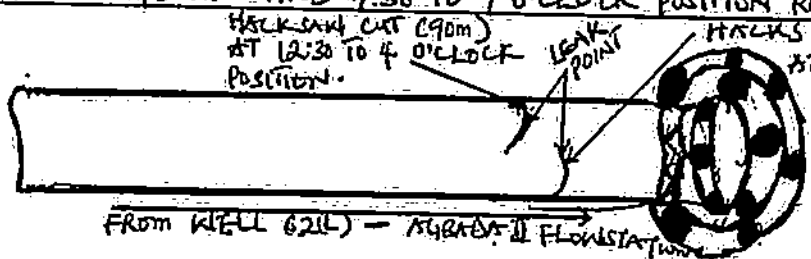
E. GRAPHIC DESCRIPTION OF LEAK POINT (while detail report of the leak point should be contained in the leak report, overview sketch of the site should be added as an appendix 1) A SECTION OF AGBADA II WELL 62(L) FLOWLINE AT OMIKEKE SHOWING 2 NOS OF HACKSAW CUT OF 90mm AND 30mm AT 12:30 TO 4 O'CLOCK POSITION AND 7:30 TO 9 O'CLOCK POSITION RESPECTIVELY BY UNKNOWN PERSONS
