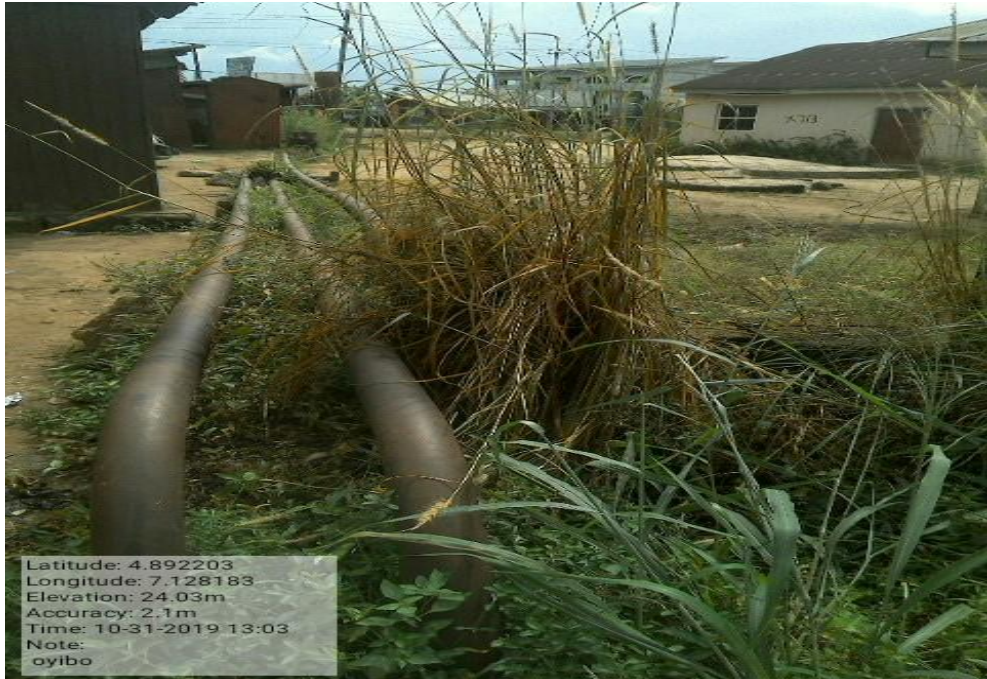
Overview: Part of spill impact on 4" Obigbo Well 38 & 52 Flowline at Umuebulu. Picture was taken during Joint Investigation of 31st October 2019.

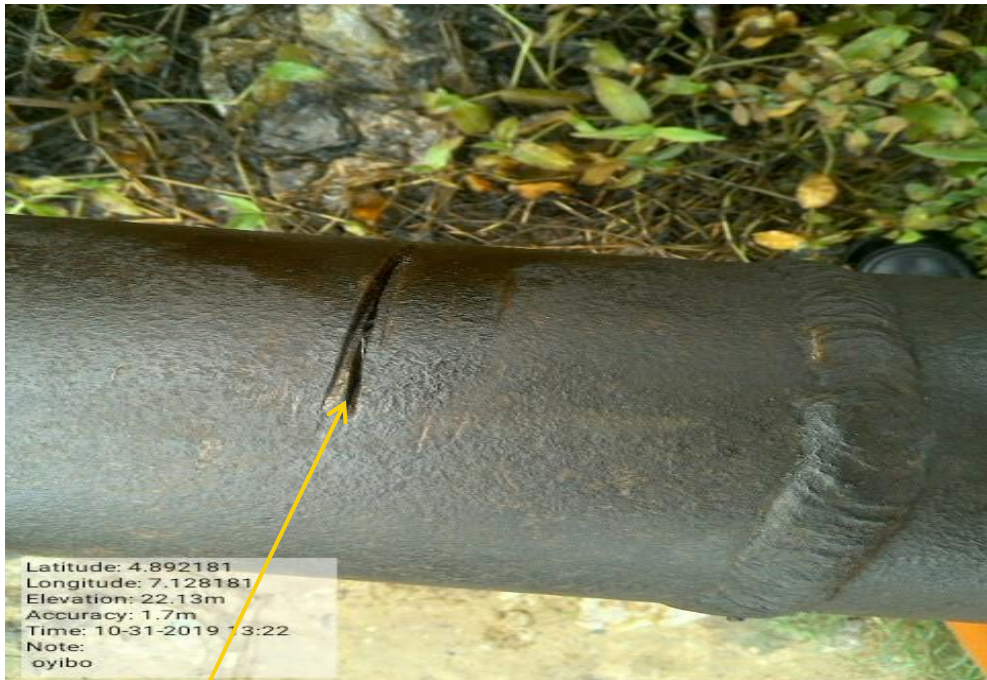
Close-up: Hack Saw Cut on 4" Obigbo Well 38 & 52 Flowline at Umuebulu. Picture was taken during Joint Investigation of 31st October 2019.
