JOINT INVESTIGATION REPORT

INCIDENT NO: 2460487 JIV report S/N: 1030115

1. Fountian Incident Number: 2460487 2. Type of incident* OIL SPILL
3. Name of Location 4" OBELLE - IBA A DELIVERY LINE
4. Name of nearest community IBA A 5. State: RIVERS 6. LGA EMOHUA
7. Type of Production facility/Installation: OIL PIPELINE
8. Asset owner/District THE SHELL PETROLEUM DEVELOPMENT COMPANY OF NIGERIA LTD (S P D C) / PIPELINE

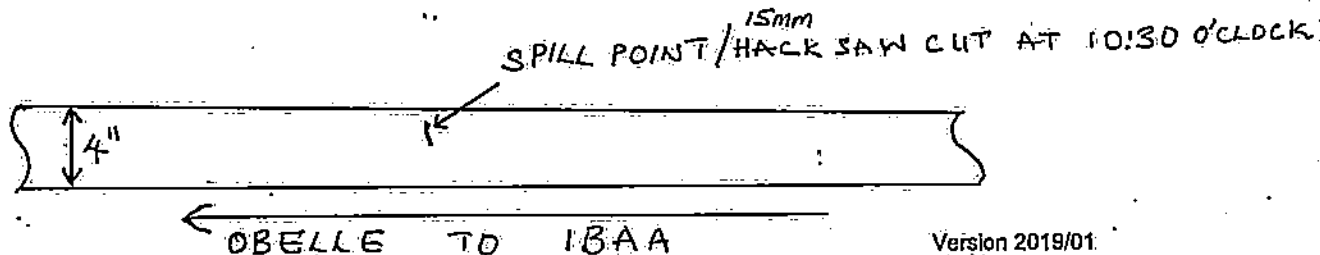
E. GRAPHIC DESCRIPTION OF LEAK POINT (while detail report of the leak point should be contained in the leak report, overview sketch of the site should be added as an appendix 1) A SECTION OF 4" OBELLE - IBAA DELIVERY LINE AT IBAA SHOWING 15mm HACK SAW CUT AT 10:30 O'CLOCK DONE BY UNKNOWN PERSONS.

REPAIR BY CLAMPING
