# JOINT INVESTIGATION REPORT

INCIDENT NO: 2624325 JIV report S/N: 0500

1. Fountain Incident Number: 2624325 2. Type of incident\* OIL SPILL  
3. Name of Location 18" ASSA - RUMUKEPE PIPELINE  
4. Name of nearest community OCHIA-AWIARA 5. State: IMO 6. LGA DHAJI EGBEMA  
7. Production Facility/Installation OIL PIPELINE  
8. Asset Owner/Hub THE SHELL PETROLEUM DEVELOPMENT COMPANY  
OF NIGERIA LIMITED / PIPELINE

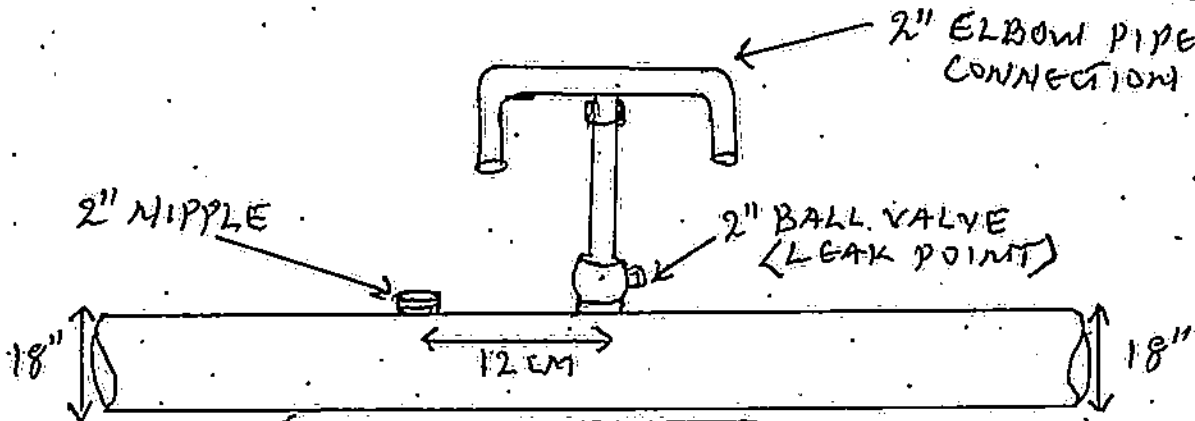
| <input checked="" type="checkbox"/> Failed Weld-on illegal hot tap valve | <input type="checkbox"/> Failed Clamp, | <input type="checkbox"/> Missing Pipeline/Flowline |
| <input checked="" type="checkbox"/> Crude oil theft (illegal bunkering) point, | <input type="checkbox"/> Saver-pit over flow | <input type="checkbox"/> Third party tampering with Clamp |

SECTION OF 18" ASSA - RUMUEKPE PIPELINE AT DCHIA-AWARA SHOWING CRUDE OIL THEFT POINTS AT 12 O'CLOCK POSITION.

REPAIR WORK ONGOING
