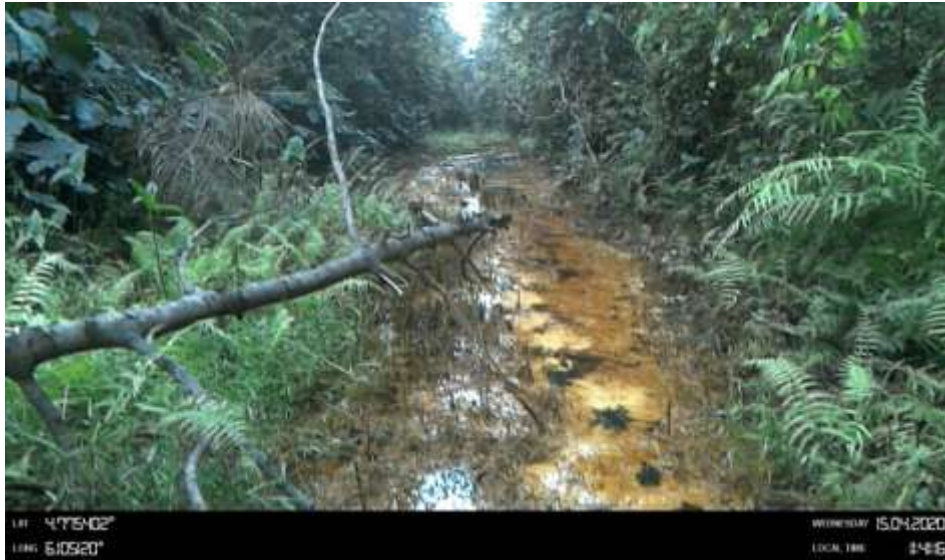
Overview: Part of spill impact on 10" Diebu Creek Nun-River Pipeline at Osokama-Oporoma. Picture was taken during Joint Investigation of 15th April 2020.

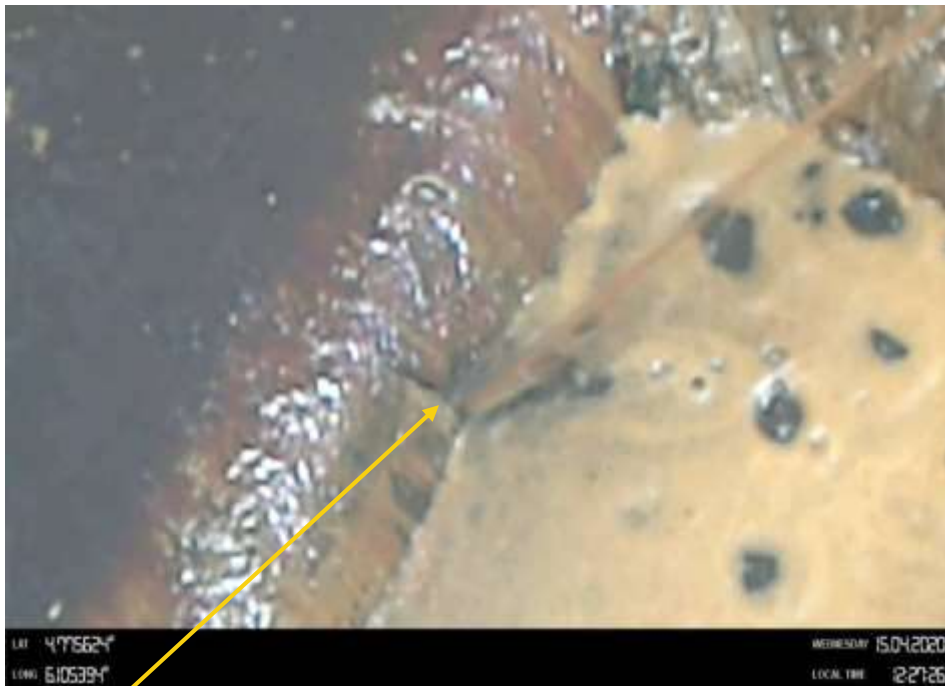
Close-up: 12mm Hacksaw cut at 11 o'clock position on 10" Diebu Creek Nun-River Pipeline at Osokama-Oporoma. Picture was taken during Joint Investigation of 15th April 2020.
