JOINT INVESTIGATION REPORT

INCIDENT NO: 2623150 JIV report S/N: 0481

1. Fountain Incident Number: 2623150 2. Type of incident* FIRE / OIL SPILL
3. Name of Location 20" KOLOCREEK - RUMUEKPE (TRUNKLINE) PIPELINE
4. Name of nearest community ODRU (KM 10) 5. State: RIVERS 6. LGA ABUA / ODUAL
7. Production Facility/Installation OIL PIPELINE.
8. Asset Owner/Hub THE SHELL PETROLEUM DEVELOPMENT COMPANY OF NIGERIA LIMITED PIPELINE.

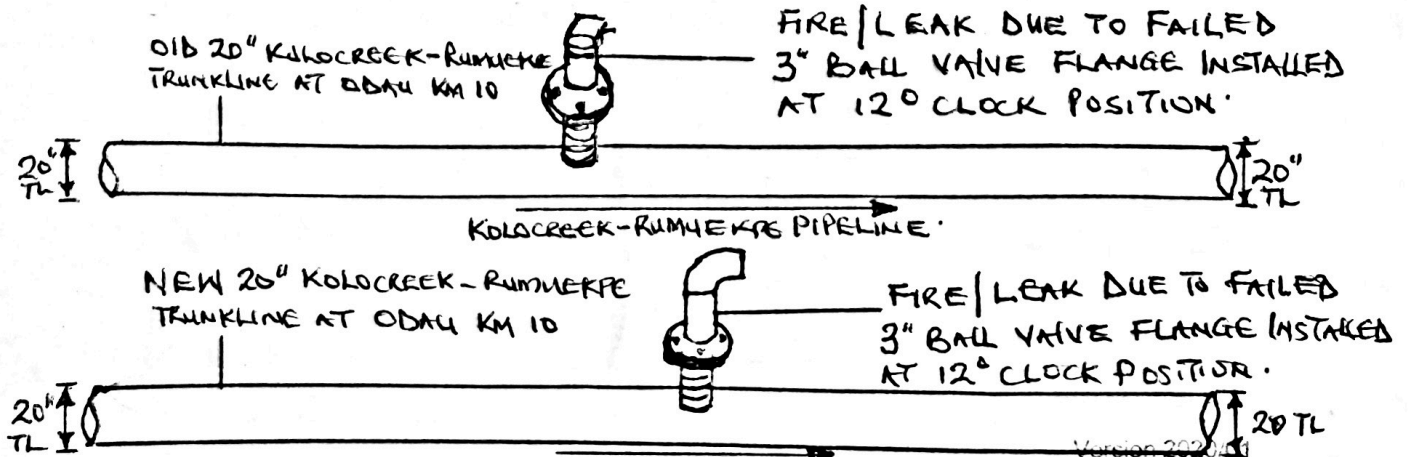
THE JOINT INVESTIGATION TEAM OBSERVED THAT THE FIRE ON BOTH THE OLD AND NEW 20" KOLOCREEK - RUMUEKPE PIPELINE AT ODRU (KM 10) WAS MERGED AS ONE INCIDENT.

| <input checked="" type="checkbox"/> Failed Weld-on illegal hot tap valve | <input type="checkbox"/> Failed Clamp, | <input type="checkbox"/> Missing Pipeline/Flowline |
| <input checked="" type="checkbox"/> Crude oil theft (illegal bunkering) point, | <input type="checkbox"/> Saver-pit over flow | <input type="checkbox"/> Third party tampering with Clamp |

SECTIONAL VIEW OF 20" KOLOCREEK-RUMUEKPE (TRUNKLINE) PIPELINE AT ODAU (KM 10) SHOWING FAILED 3" THEFT FITTINGS

TEMPORARY REPAIR WORK BY BLIND FLANGING COMPLETED WHILE OIL SPILL RECOVERY WORK IS ONGOING.
