# JOINT INVESTIGATION REPORT

INCIDENT NO: 2623209 JIV report S/N: 0490

1. Fountain Incident Number: 2623209 2. Type of incident\* OIL SPILL  
3. Name of Location 20<sup>th</sup> KOLUCRCEK - RUMURKPE (TRUNKLINE) PIPELINE  
4. Name of nearest community ODAU (KM 9) 5. State: RIVERS 6. LGA ABYA/ODUAL  
7. Production Facility/Installation OIL PIPELINE  
8. Asset Owner/Hub THE SHELL PETROLEUM DEVELOPMENT COMPANY OF NIGERIA LIMITED PIPELINE

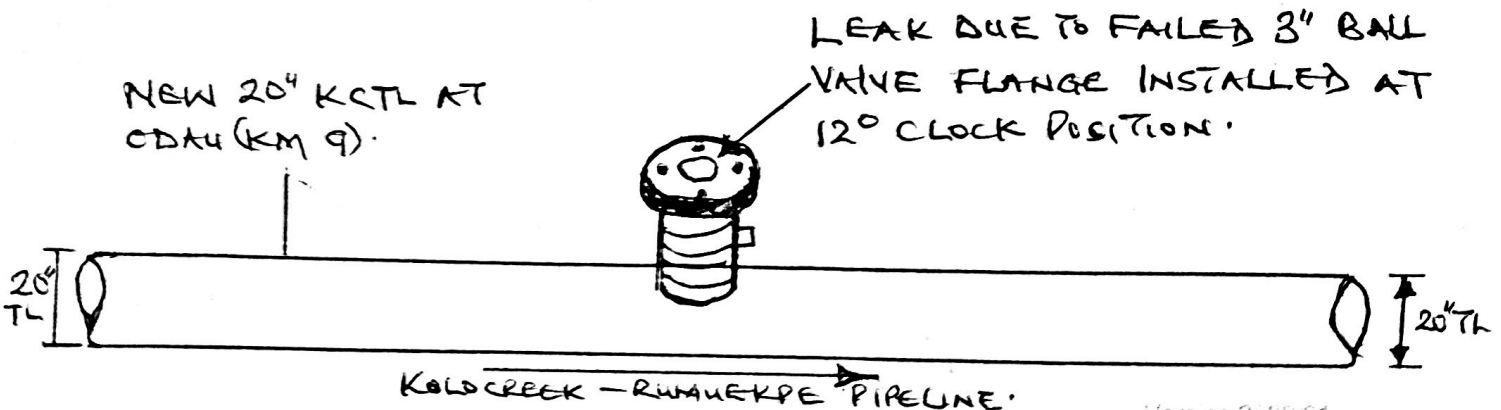
| <input checked="" type="checkbox"/> Failed Weld-on illegal hot tap valve | <input type="checkbox"/> Failed Clamp, | <input type="checkbox"/> Missing Pipeline/Flowline |
| <input checked="" type="checkbox"/> Crude oil theft (illegal bunkering) point, | <input type="checkbox"/> Saver-pit over flow | <input type="checkbox"/> Third party tampering with Clamp |

SECTIONAL VIEW OF 20" KOLDCREEK - RUMUEKPE (TRUNKLINE) PIPELINE AT ODAU (KM 9). SHOWING:- FAILED 3" THEFT FITTINGS.

TEMPORARY REPAIR WORK BY BLIND FLANGING COMPLETED.  
WHILE OIL SPILL RECOVERY WORK IS ONGOING.
