JOINT INVESTIGATION REPORT

INCIDENT NO: 2623394 JIV report S/N: 0482

1. Fountain Incident Number: 2623394 2. Type of incident* FIRE/OIL SPILL
3. Name of Location 20" KOLOCREEK - RUMUEKPE (TRUNKLINE) PIPELINE
4. Name of nearest community ODAU (KM 9.4) State: RIVERS 6. LGA ARUA/ODUAL
7. Production Facility/Installation OIL PIPELINE
8. Asset Owner/Hub THE SHELL PETROLEUM DEVELOPMENT COMPANY OF NIGERIA LIMITED/PIPELINE

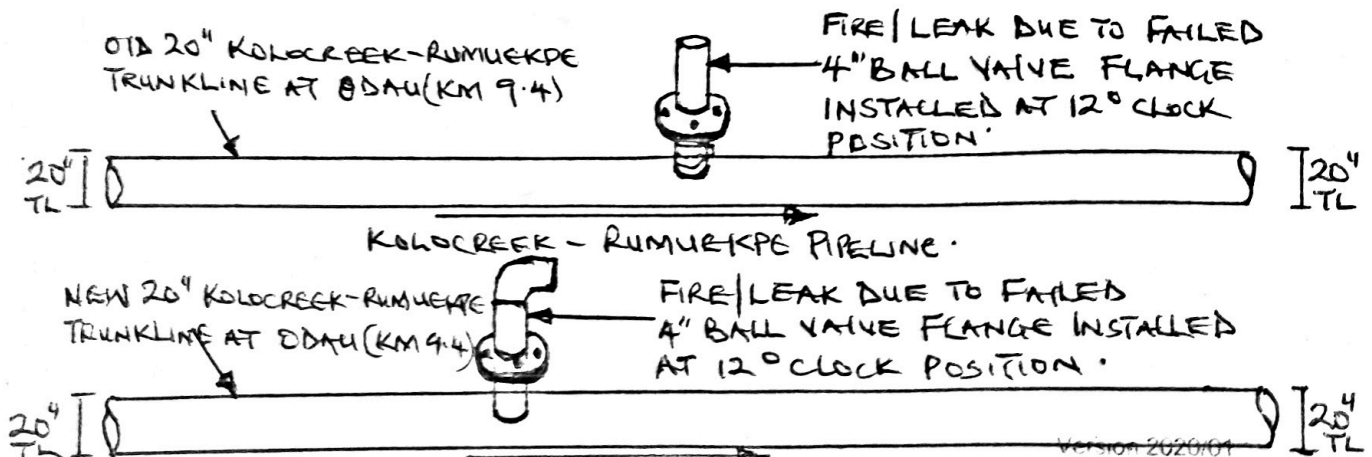
THE JOINT INVESTIGATION TEAM OBSERVED THAT THE FIRE ON BOTH THE OLD AND NEW 20" KOLOCREEK - RUMUEKPE PIPELINE AT ODAU KM 9.4 WAS MERGED AS ONE INCIDENT.

| <input checked="" type="checkbox"/> Failed Weld-on illegal hot tap valve | <input type="checkbox"/> Failed Clamp, | <input type="checkbox"/> Missing Pipeline/Flowline |
| <input checked="" type="checkbox"/> Crude oil theft (illegal bunkering) point, | <input type="checkbox"/> Saver-pit over flow | <input type="checkbox"/> Third party tampering with Clamp |

SECTIONAL VIEW OF 20" KOLOCREEK-RUMUEKPE (TRUNKLINE) PIPELINE AT ODAU (KM 9.4) SHOWING :- FAILED 4" TEE FITTINGS

TEMPORARY REPAIR WORK BY BLIND FLANGING COMPLETED WHILE OIL SPILL RECOVERY WORK IS ONGOING
