JOINT INVESTIGATION REPORT

INCIDENT NO: 2625566 JIV report S/N: 0503

1. Fountain Incident Number: 2625566 2. Type of incident* OIL SPILL/FIRE
3. Name of Location 14" OKORDIA - RUMUEKPE PIPELINE
4. Name of nearest community IHYOWO 5. State: RIVERS 6. LGA ATHADA EAST
7. Production Facility/Installation OIL PIPELINE
8. Asset Owner/Hub THE SHELL PETROLEUM DEVELOPMENT COMPANY OF NIGERIA LTD (SPDC)/PIPELINE

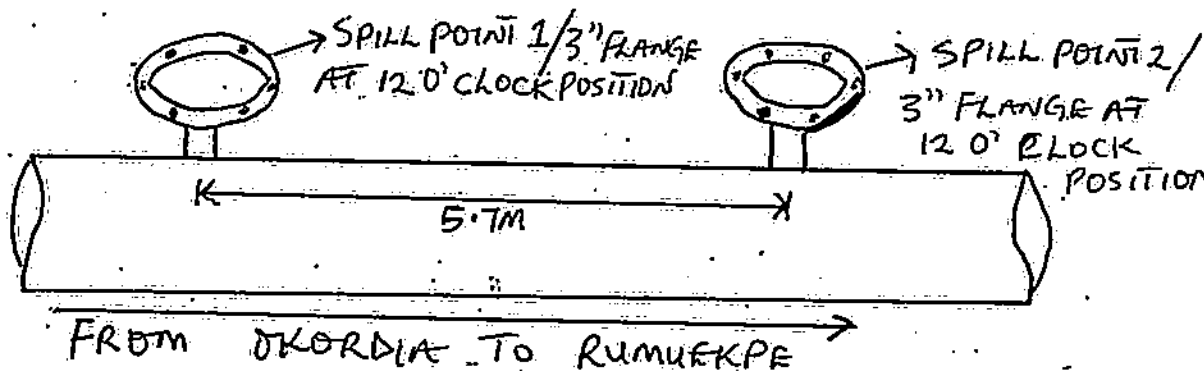
E. GRAPHIC DESCRIPTION OF LEAK POINT (while detailed description of the leak point should be contained in the leak report, overview sketch of the site should be added as appendix 1)

A SECTION OF 14" OKORDIA-RUMUEKPE PIPELINE AT ITHUOND SHOWING 2 NOS 3" WELD NECK FLANGE CRUDE THEFT POINTS AT 12 O'CLOCK POSITION. ILLEGALLY INSTALLED BY UNKNOWN PERSONS.

REPAIR BY CLAMPING
