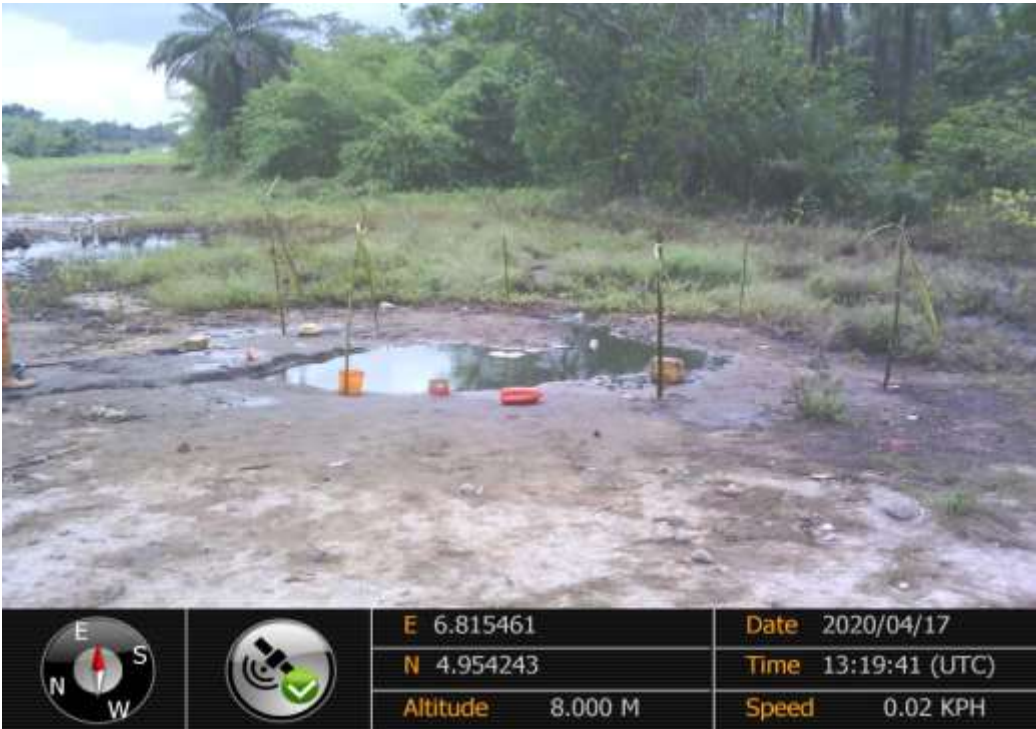
**Overview:** Part of spill impact on 20" Rumuekpe Nkpoku Pipeline at Ibaa. Picture was taken during Joint Investigation of 17<sup>th</sup> April 2020.

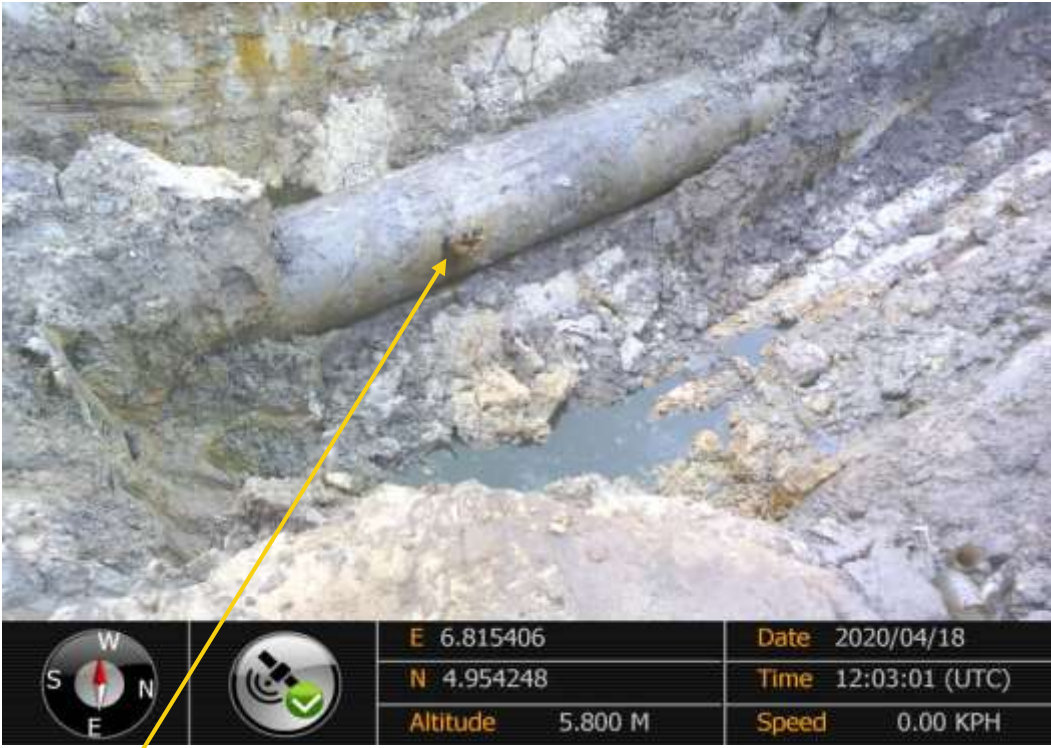
**Close-up:** 10mm drilled hole at 3 o'clock position on 20" Rumuekpe Nkpoku Pipeline at Ibaa. Picture was taken during Joint Investigation of 18<sup>th</sup> April 2020.
