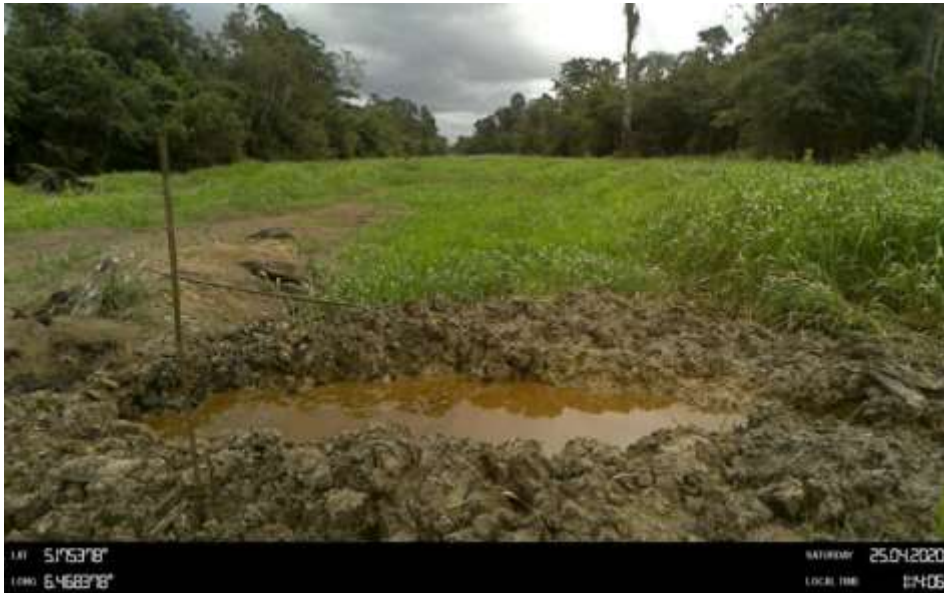
Overview: Part of spill impact on 12" Adibawa Okordia Pipeline at Ikarama. Picture was taken during Joint Investigation of 25th April 2020.

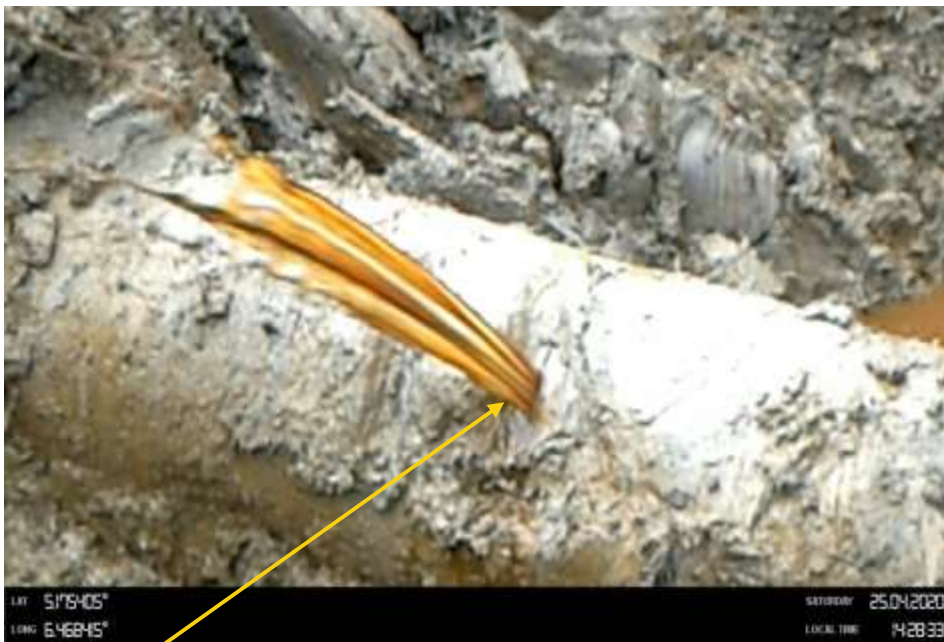
Close-up: 15mm Hacksaw cut at 11 o'clock position on 12" Adibawa Okordia Pipeline at Ikarama. Picture was taken during Joint Investigation of 25th April 2020.
