JOINT INVESTIGATION REPORT

INCIDENT NO: 2630205 JIV report S/N: 0493

1. Fountain Incident Number: 2630205 2. Type of incident* OIL SPILL
3. Name of Location 12" ADIBAWA - OKORDIA PIPELINE
4. Name of nearest community IKARAMA 5. State: BAYELSA 6. LGA YENAGOA
7. Production Facility/Installation OIL PIPELINE
8. Asset Owner/Hub THE SHELL PETROLEUM DEVELOPMENT COMPANY OF NIGERIA LIMITED (SPDC)/PIPELINE

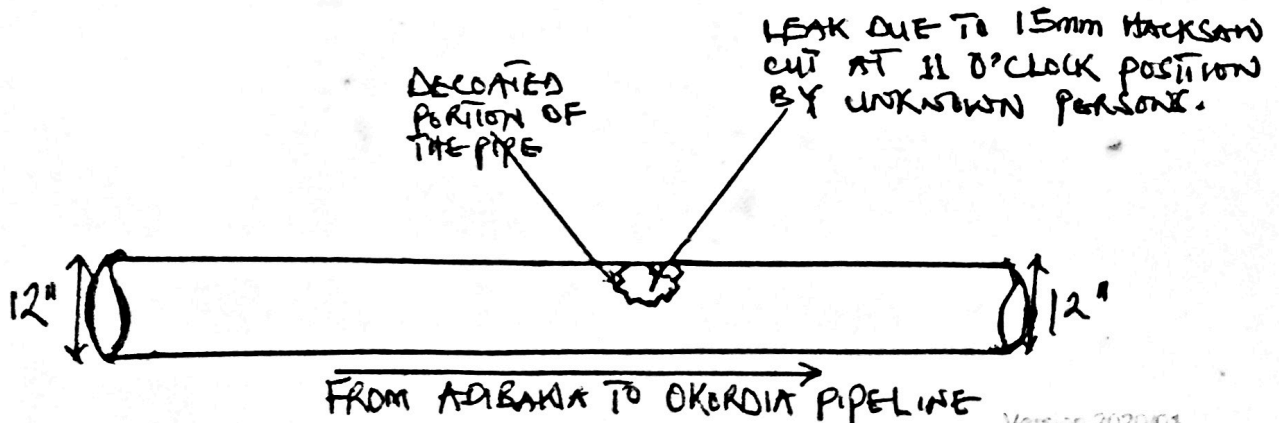
E. GRAPHIC DESCRIPTION OF LEAK POINT (while detailed description of the leak point should be contained in the leak report, overview sketch of the site should be added as appendix 1.) A SECTION OF 12" ADIBAWA - OKORDIA PIPELINE AT UKARAMA SHOWING A 15mm HACKSAW CUT AT 11 O'CLOCK POSITION BY UNKNOWN PERSONS.
