Overview: Part of spill impact on 16" Tunu – Brasscreek Pipeline at Agbidiama. Picture was taken during Joint Investigation of 24th April 2020.

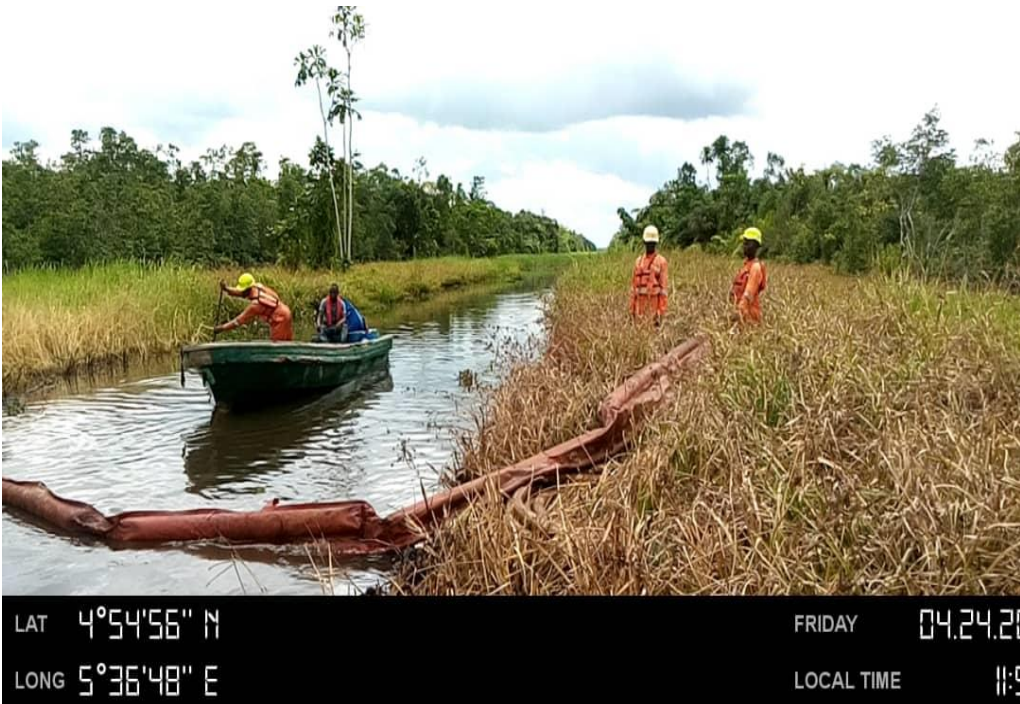
Overview: Part of spill impact on 16" Tunu – Brasscreek Pipeline at Agbidiama. Picture was taken during Joint Investigation of 24th April 2020.

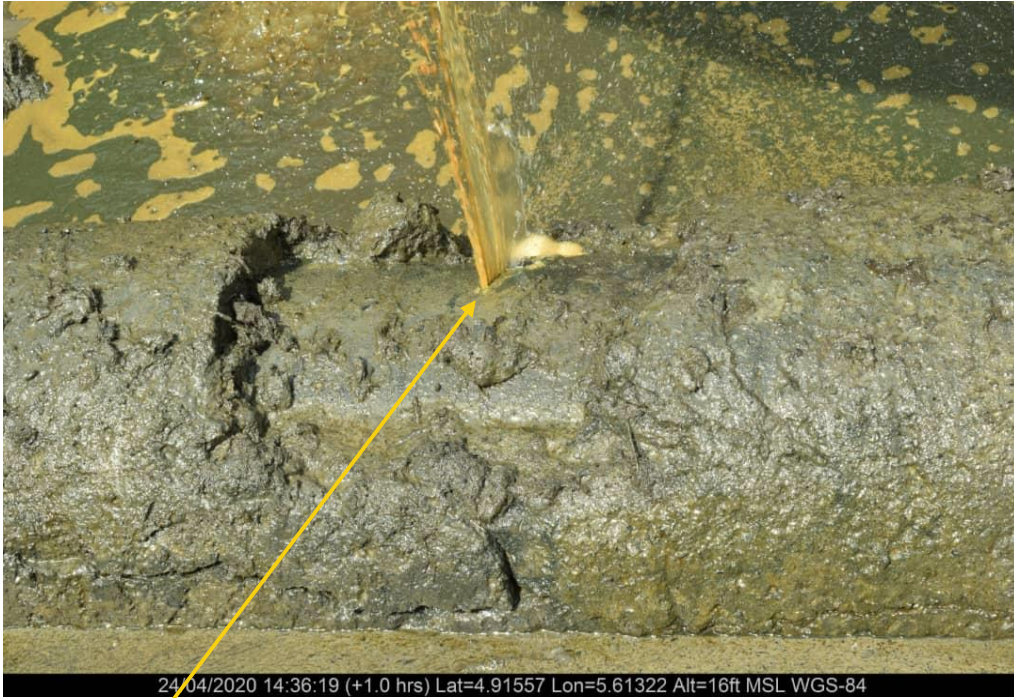
Close-up: Hack Saw Cut at 1 o'clock position on 16" Tunu – Brasscreek Pipeline at Agbidiana. Picture was taken during Joint Investigation of 24th April 2020.
