JOINT INVESTIGATION REPORT

INCIDENT NO: 2627808 JIV report S/N: 0716

1. Fountain Incident Number: 2627808 2. Type of incident* OIL SPILL / FIRE
3. Name of Location 16" TUNU DELIVERY LINE RIGHT OF WAY
4. Name of nearest community AGBIDIAMAS. State: BAYELSA 6. LGA EKEREMOR
7. Production Facility/Installation CRUDE OIL PIPELINE
8. Asset Owner/Hub THE SHELL PETROLEUM DEVELOPMENT COMPANY NIGERIA LIMITED / PIPELINE

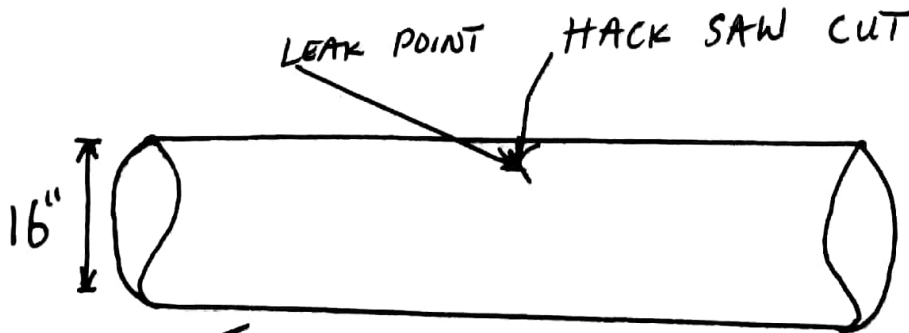
A SECTION OF 16" TUNU DELIVERY LINE RIGHT OF WAY AT TUNU SHOWING HACK SAW CUT AT 1 O'CLOCK POSITION

FLOWING FROM TUNU TO BRASS CREEK.

| <input type="checkbox"/> Smooth round-edge hole | <input type="checkbox"/> Rough-edge hole | <input checked="" type="checkbox"/> Hack saw cut |

- Third party interference (Sabotage ; crude theft ; Line theft ; Accidental 3rd party damage
 Operational Others (including Mystery spills) _____

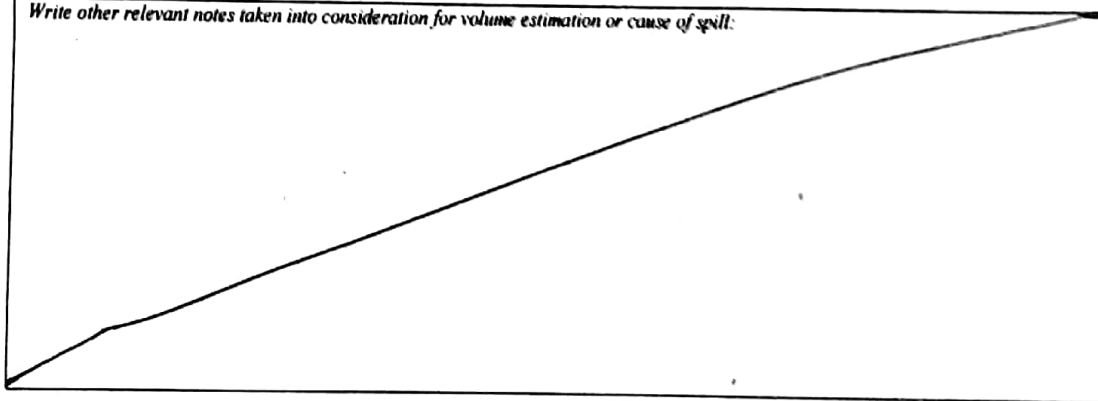
- Volume estimation was done using an excel based tool. (see attached for details on the calculation)
- Reported spilled volume is an estimate

Write other relevant notes taken into consideration for volume estimation or cause of spill:
