Overview: Part of spill impact on 14" Okordia - Rumuekpe Pipeline at Edeoha. Picture was taken during Joint Investigation on 1st August 2020.

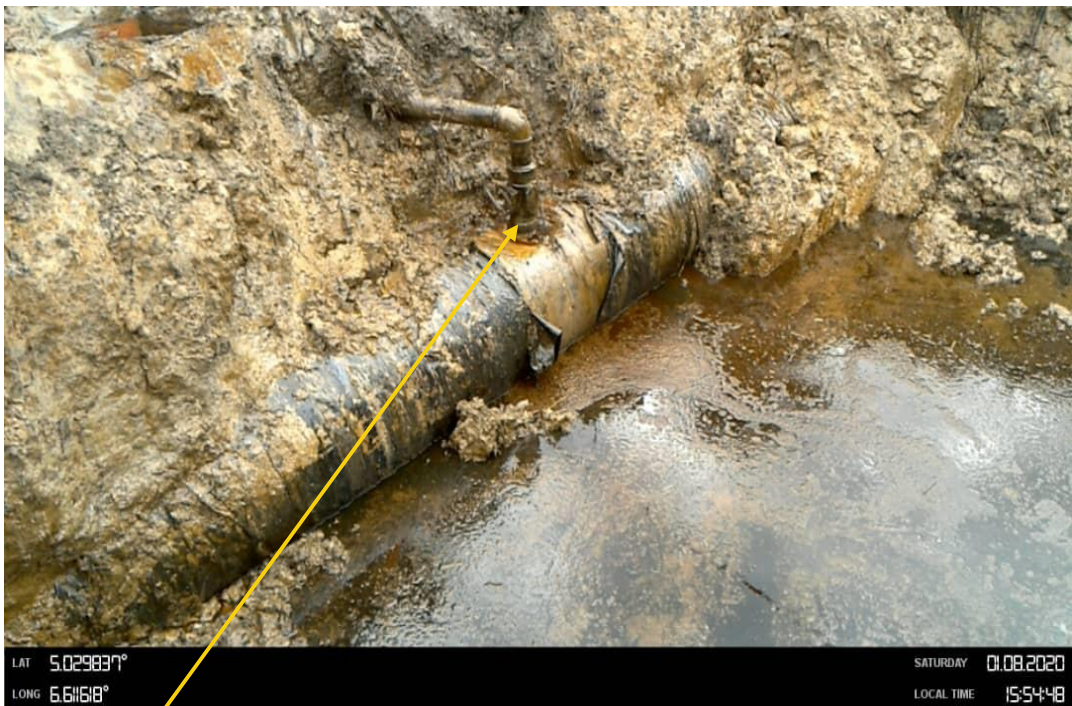
Close-up: 2" gate valve and 2" galvanized pipe installed at 12 o'clock position on 14" Okordia Rumuekpe Pipeline at Edeoha. Picture was taken during Joint Investigation on 1st August 2020.
