JOINT INVESTIGATION REPORT

INCIDENT NO: 2701311 JIV report S/N: 0575

1. Fountain Incident Number: 2701311 2. Type of incident: OIL SPILL
3. Name of Location: 12" MO RIVER 2 - OGALE PIPELINE
4. Name of nearest community: UMUOLOLO 5. State: ABIA 6. LGA: UKWA WEST
7. Production Facility/Installation: CRUDE OIL PIPELINE
8. Asset Owner/Hub: THE SHELL PETROLEUM DEVELOPMENT COMPANY OF NIGERIA LIMITED (SPDC)/PIPELINE

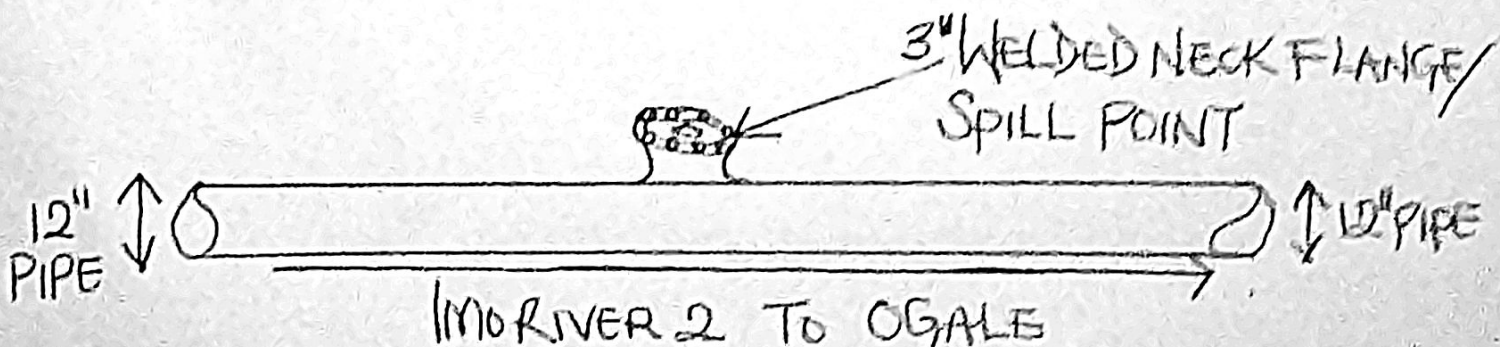
E. GRAPHIC DESCRIPTION OF LEAK POINT (while detailed description of the leak point should be contained in the leak report, overview sketch of the site should be added as appendix 1) A SECTION OF 12" IMR RIVER 2 - OGALE PIPELINE AT UMUOLOLO SHOWING A 3" WELDED NECK FLANGE (INSTALLED) AT 12 O'CLOCK POSITION BY UNKNOWN PERSON(S).

CLAMPING ON-GOING
