# JOINT INVESTIGATION REPORT

INCIDENT NO: 2703463 JIV report S/N: 0671

1. Fountain Incident Number: 2703463 2. Type of incident\* OIL SPILL  
3. Name of Location 6" IMORIVER WELL 59T FLOWLINE  
4. Name of nearest community IGIKUKWU 5. State: ABIA 6. LGA UKWA WEST  
7. Production Facility/Installation CRUDE OIL FLOWLINE  
8. Asset Owner/Hub THE SHELL PETROLEUM DEVELOPMENT COMPANY  
OF NIGERIA LIMITED / LAND EAST HUB.

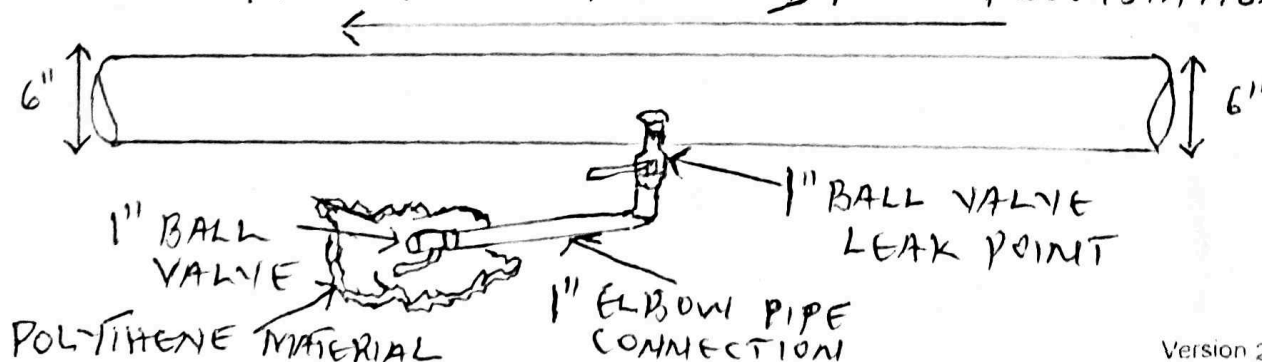
E. GRAPHIC DESCRIPTION OF LEAK POINT (while detailed description of the leak point should be contained in the leak report, overview sketch of the site should be added as appendix 1)

SECTION OF 6" IMORIVER WELL 59T FLOWLINE AT IGIRIUKWU OWAZA SHOWING CRUDE OIL THEFT POINT INSTALLED AT 7 O'CLOCK POSITION BY UNKNOWN PERSON(S).

FROM IMORIVER WELL 59T TO FLOWSTATION.
