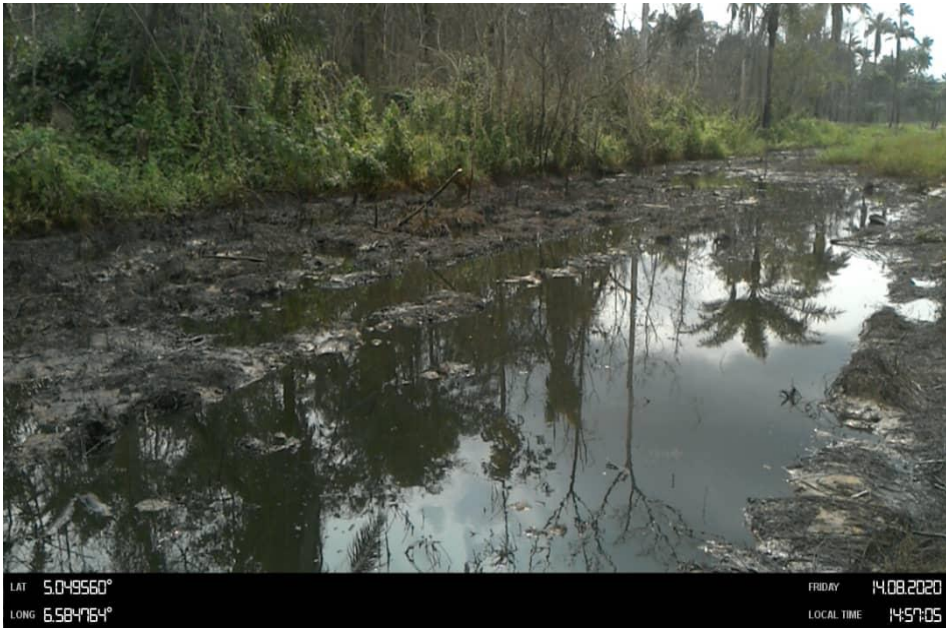
Overview: Part of spill impact on 14" Okordia Rumuekpe Pipeline at Ula-lkata. Picture was taken during Joint Investigation 14th August 2020.

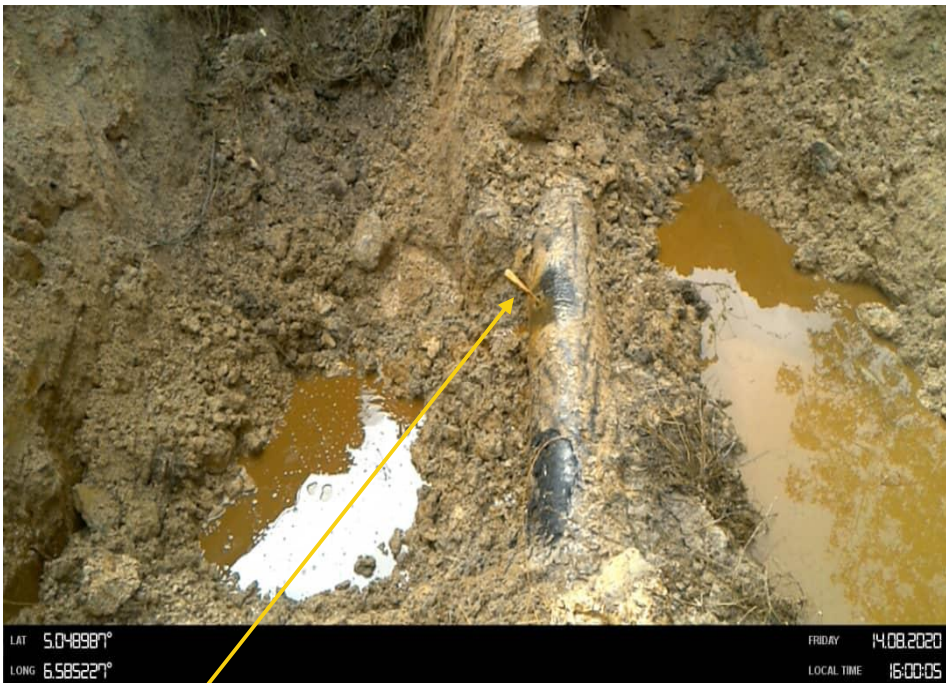
Close-up: 12mm smooth round-edge hole installed at 1 o'clock position on 14" Okordia Rumuekpe Pipeline at Ula-lkata. Picture was taken during Joint Investigation 14th August 2020.
