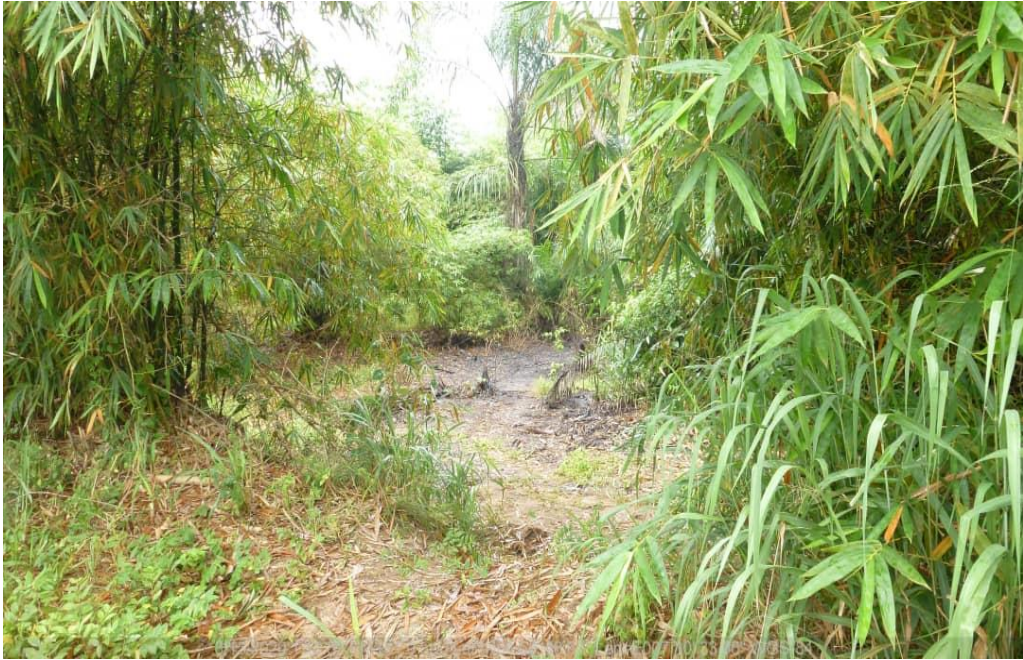
Overview: Part of spill impact on 4" Imo River2 – Imo River1 Bulcline at Igiriukwu - Isietitiuzo - Owaza. Picture was taken during Joint Investigation of 15th August 2020.

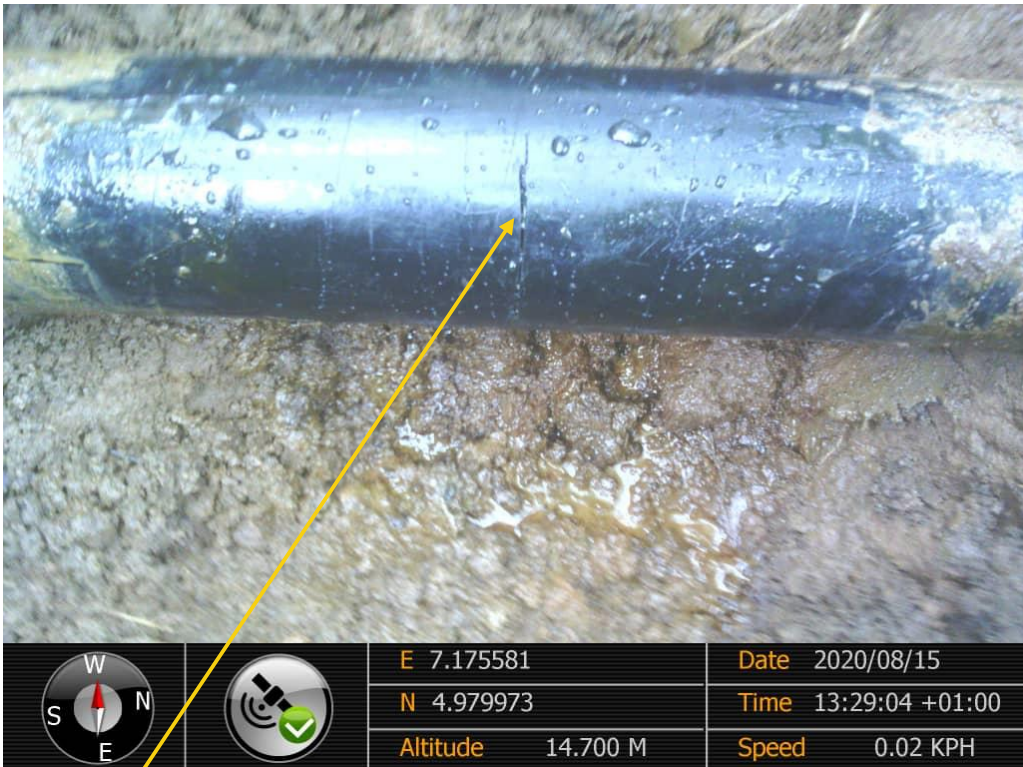
Close-up: Hack Saw Cut at 1 o'clock to 5 o'clock position on 4" Imo River2 – Imo River1 Bulcline at Igiriukwu - Isietitiuzo -Owaza. Picture was taken during Joint Investigation of 15th August 2020.
