Overview: Part of spill impact on 12" ImoRiver2- Ogale Pipeline at Igiriukwu-Isietitioha Owaza. Picture was taken during Joint Investigation on 26th August 2020.

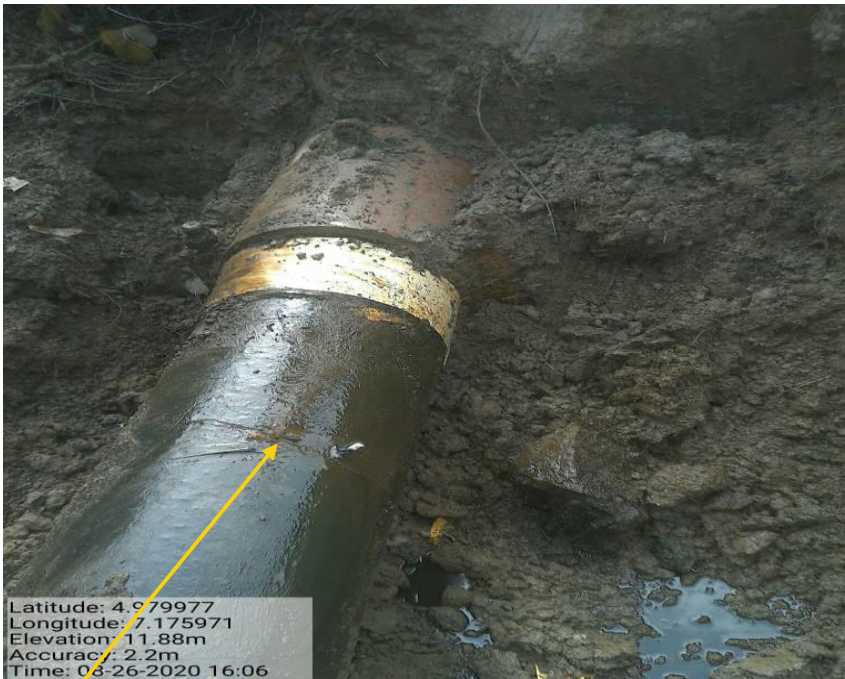
Close-up: Hacksaw cut at 11 o'clock position on 12" ImoRiver2- Ogale Pipeline at Igiriukwu-Isietitioha Owaza. Picture was taken during Joint Investigation on 26th August 2020.
