JOINT INVESTIGATION REPORT

INCIDENT NO: 2714325 JIV report S/N: 0679

1. Fountain Incident Number: 2714325 2. Type of incident* OIL SPILL
3. Name of Location 12" IMO RIVER 2 - OGALE PIPELINE
4. Name of nearest community IGIALUKWU - ISI ETI OHA 5. State: ABIA 6. LGA Ukwa West
7. Production Facility/Installation: CRUDE OIL PIPELINE
8. Asset Owner/Hub THE SHELL PETROLEUM DEVELOPMENT COMPANY

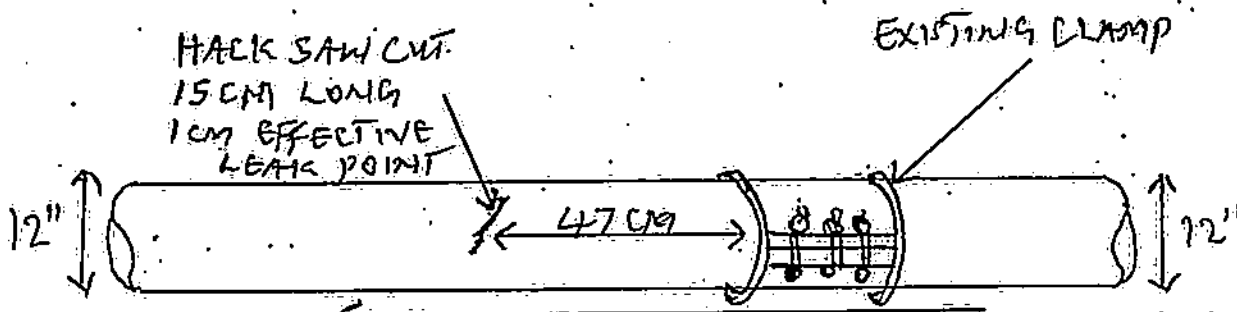
E. GRAPHIC DESCRIPTION OF LEAK POINT (while detailed description of the leak point should be contained in the leak report, overview sketch of the site should be added as appendix 1)

SECTION OF 12" IMORIVER 2 - OGALE PIPELINE AT IGIRIKUNDU ISLETIYIHA OWAZA SHOWING HACK SAW CUT AT 1) O'CELRIC POSITION BY UNKNOWN PERSON(S).

FROM IMORIVER 2 TO OGALE
