Overview: Part of spill impact on 4" ImoRiver 1 well 36s Flowline at Isietitioha Owaza. Picture was taken during Joint Investigation on 25th August 2020.

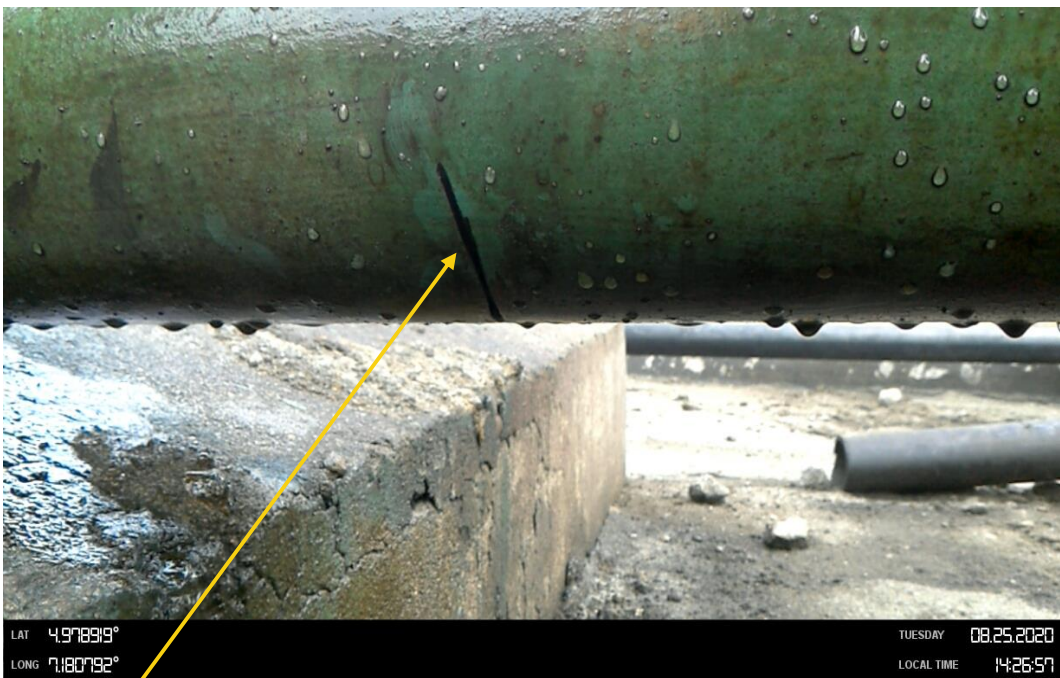
Close-up: 4cm Hacksaw cut at 5 to 6 o'clock position on 4" ImoRiver 1 well 36s Flowline at Isietitioha Owaza. Picture was taken during Joint Investigation on 25th August 2020.
