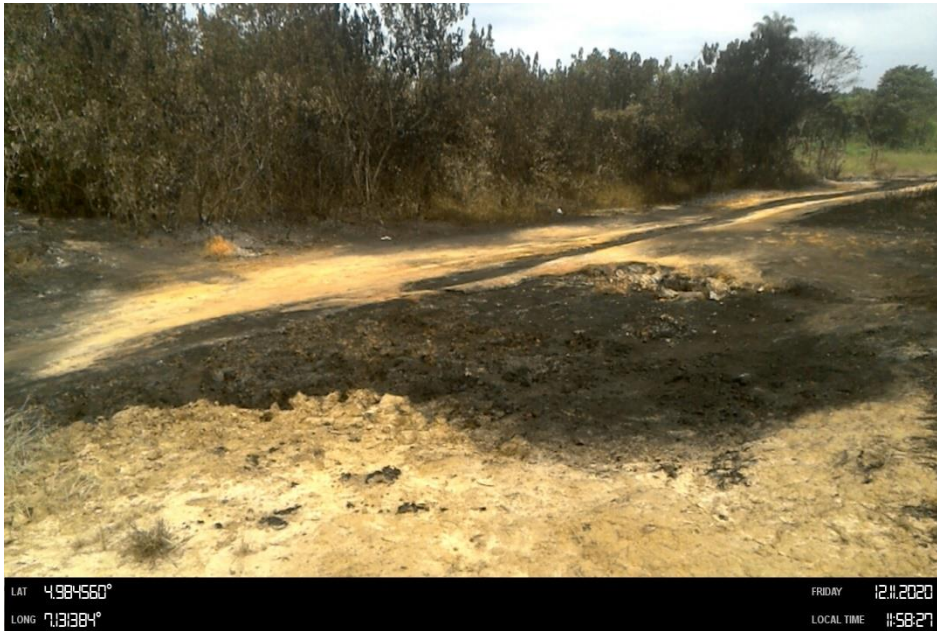
Overview: Part of spill impact on 8'' Nkali – Imo River2 Pipeline at Odagwa. Picture was taken during Joint Investigation on 11th December 2020.

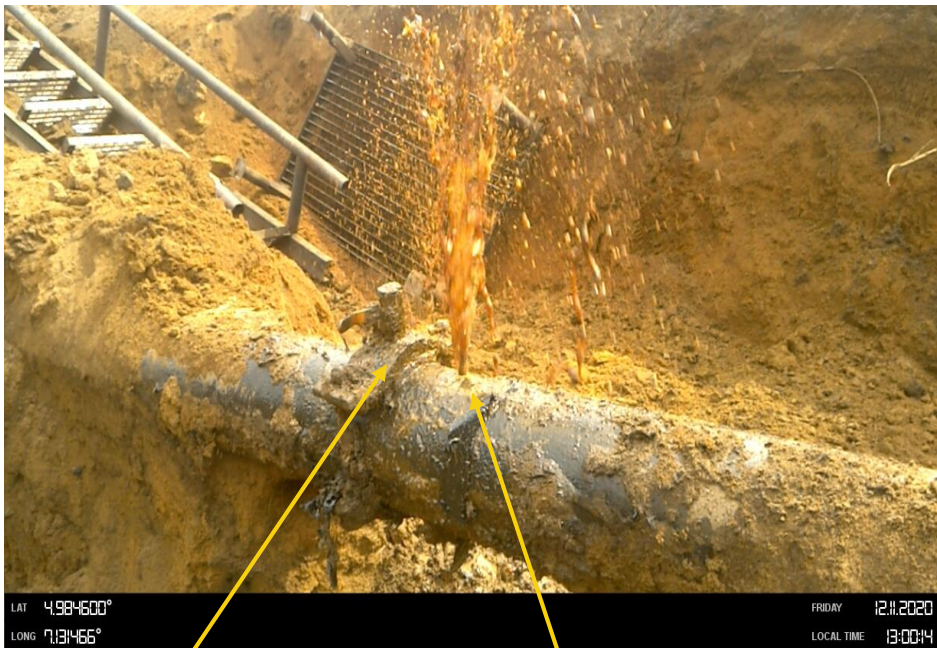
Close-up: 1 inch ball valve illegal connection and drilled hole installed at 12 o'clock position on 8'' Nkali – Imo River2 Pipeline at Odagwa. Picture was taken during Joint Investigation on 11th December 2020.
