Overview: Part of spill impact on 14" Okordia Rumuekpe Pipeine at Akinima.
Picture was taken during Joint Investigation on 30th December 2020.

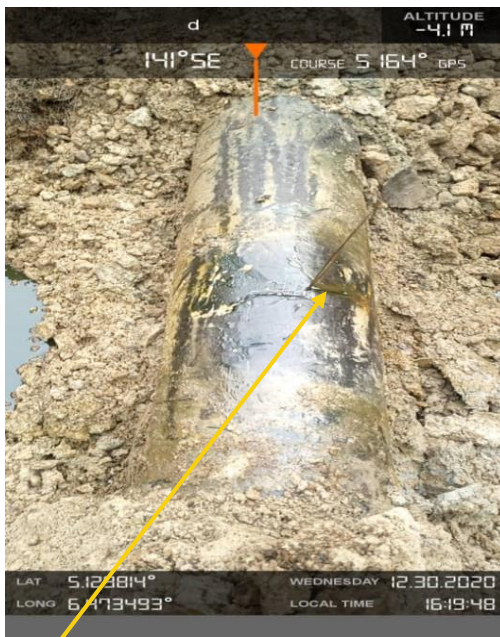
Close-up: Hack Saw Cut at 12:30 o'clock position on 14" Okordia Rumuekpe Pipeine at Akinima.
Picture was taken during Joint Investigation on 30th December 2020.
