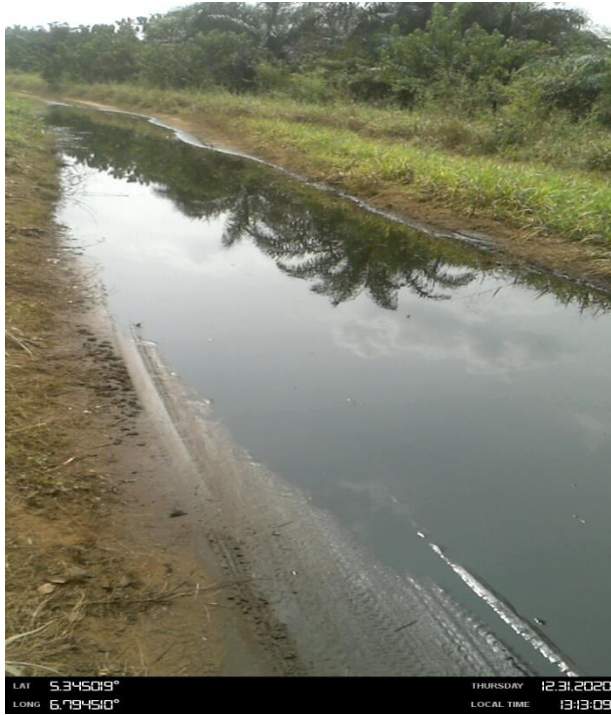
Overview: Part of spill impact on 18" Assa - Rumuekpe Pipeline Right of Way at Ochia. Picture was taken during Joint Investigation of 31st December 2020.

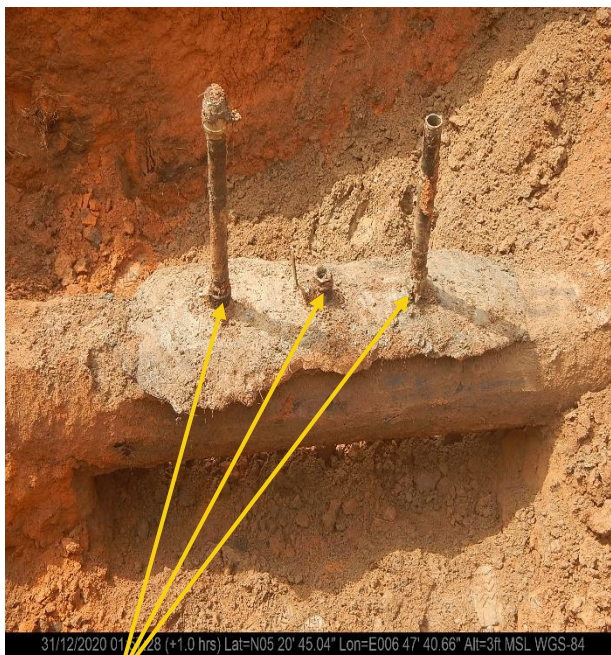
Close-up: 3nos of crude oil theft points installed at 12 o'clock position on 18" Assa - Rumuekpe Pipeline at Ochia. Picture was taken during Joint Investigation of 31st December 2020.
