JOINT INVESTIGATION REPORT

INCIDENT NO: 2812730 JIV report S/N: 0598

1. Fountain Incident Number: 2812730 2. Type of incident* OIL SPILL
3. Name of Location 20" KOLOCREEK - RUMUEKPE PIPELINE
4. Name of nearest community OWEREWERE 5. State: RIVERS 6. LGA ABUA/ODUAL
7. Production Facility/Installation OIL PIPELINE
8. Asset Owner/Hub THE SHELL PETROLEUM DEVELOPMENT COMPANY OF NIGERIA LIMITED (SPDC) PIPELINE

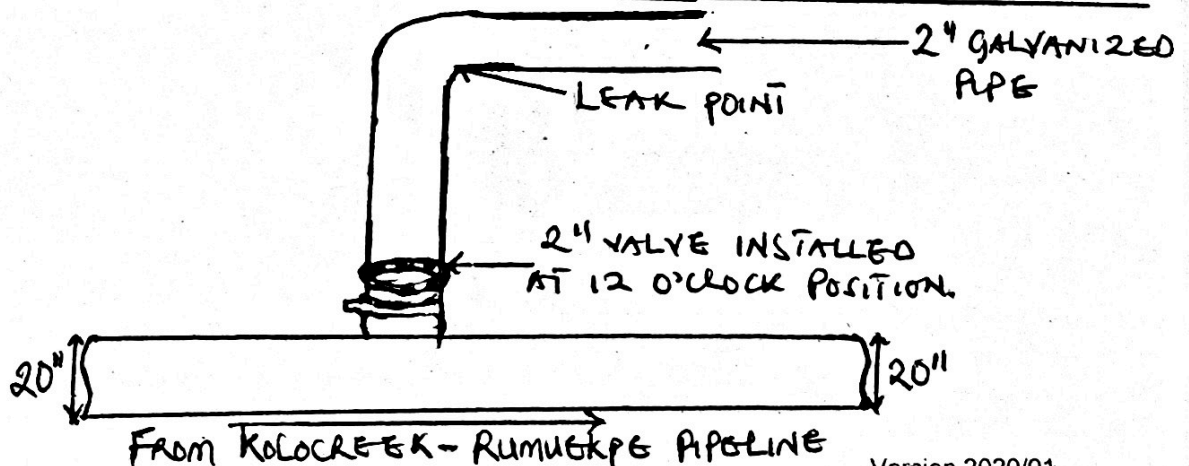
| <input checked="" type="checkbox"/> Crude oil theft (illegal bunkering) point, | <input type="checkbox"/> Saver-pit over flow | <input type="checkbox"/> Third party tampering with Clamp |

E. GRAPHIC DESCRIPTION OF LEAK POINT (while detailed description of the leak point should be contained in the leak report, overview sketch of the site should be added as appendix 1) A SECTION OF 20" KOLOCREEK-RUMUEKPE PIPELINE AT OWEREKERE SHOWING A 2" VALVE CONNECTED TO A 2" GALVANIZED PIPE AT 12 O'CLOCK POSITION BY UNKNOWN PERSONS.

REPAIR ACTIVITIES ONGOING
