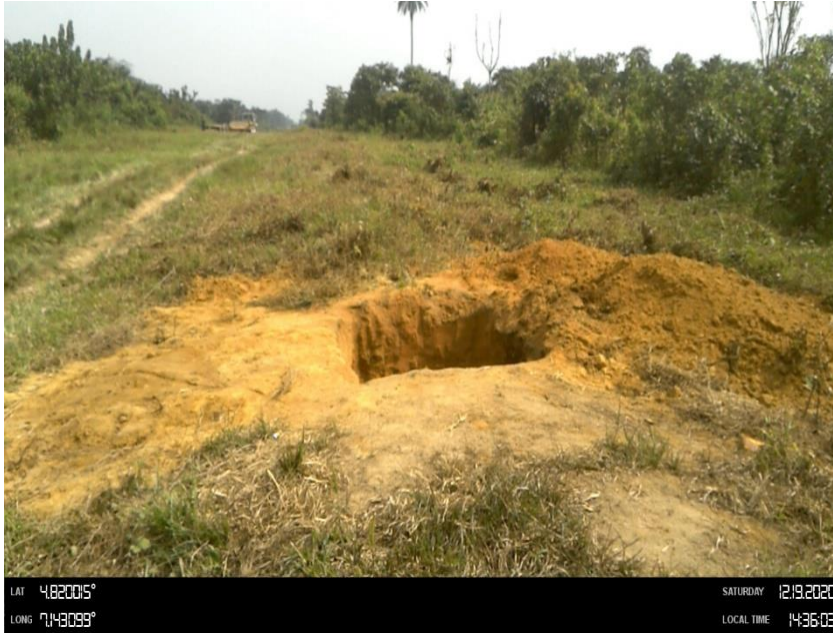
Overview: Part of spill impact on 36" Nkpoku Ogale Pipeline at Ogale.
Picture was taken during Joint Investigation on 19th Dec 2020.

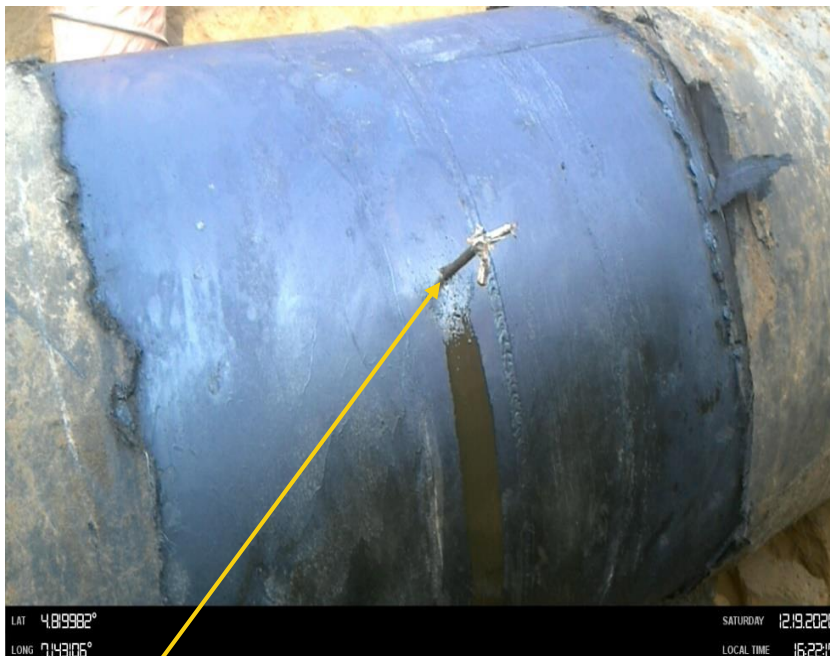
Close-up: Plugged 5mm Drilled hole at 2 o'clock position on 36" Nkpoku Ogale Pipeline at Ogale.
Picture was taken during Joint Investigation on 19th Dec 2020.
