Overview: Part of spill impact on 36'' Nkpoku Ogale Pipeline at Agbonchia.
Picture was taken during Joint Investigation on 17th Dec 2020.

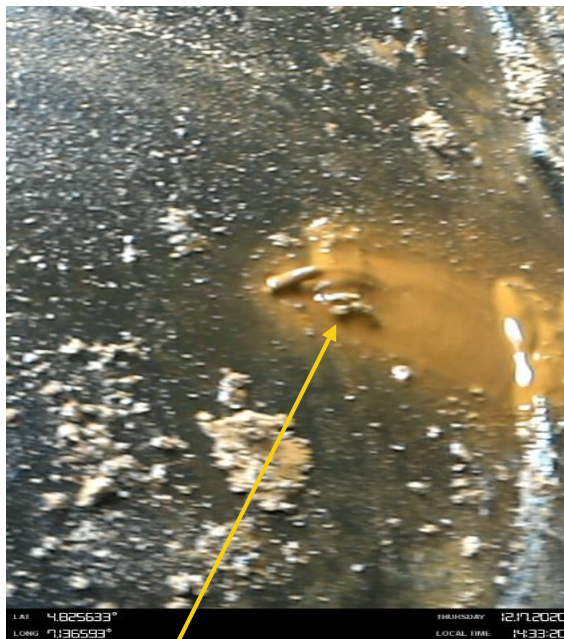
Close-up 1: 4 nos 5mm drilled hole (leak point 1) at 10 o'clock position on 36inch Nkpoku Ogale Pipeline at Agbonchia. Picture was taken during Joint Investigation on 17th Dec 2020.

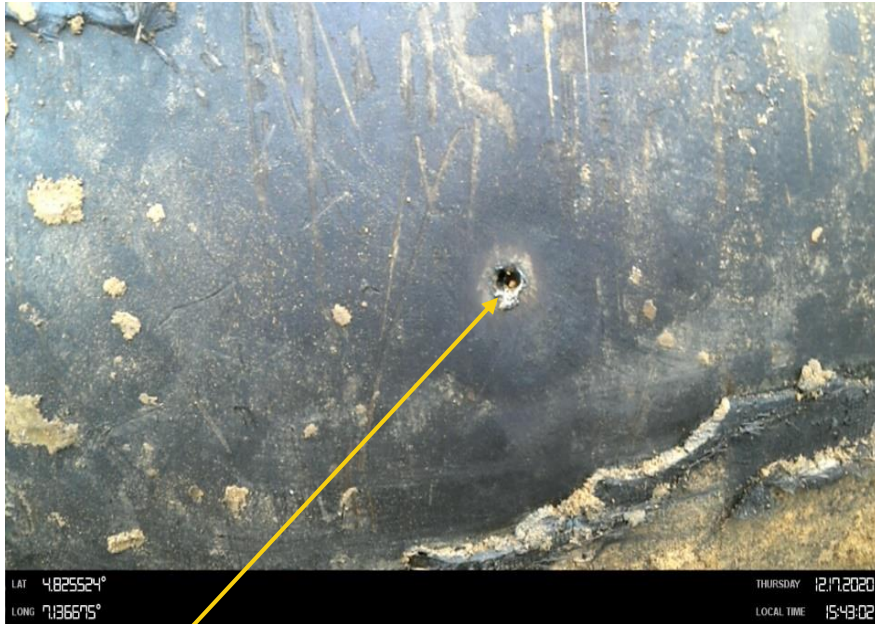
Close-up 2: 4 nos 5mm drilled hole at 2 o'clock position on 36inch Nkpoku Ogale Pipeline at Agbonchia. Picture was taken during Joint Investigation on 17th Dec 2020.

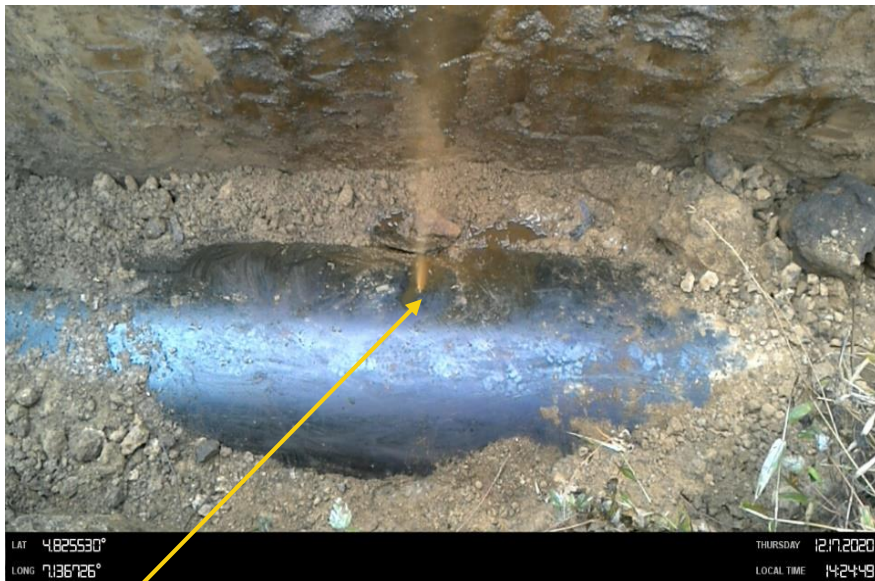
Close-up 3: 4 nos 5mm drilled hole (leak point 2) at 1 o'clock position on 36inch Nkpoku Ogale Pipeline at Agbonchia. Picture was taken during Joint Investigation on 17th Dec 2020.

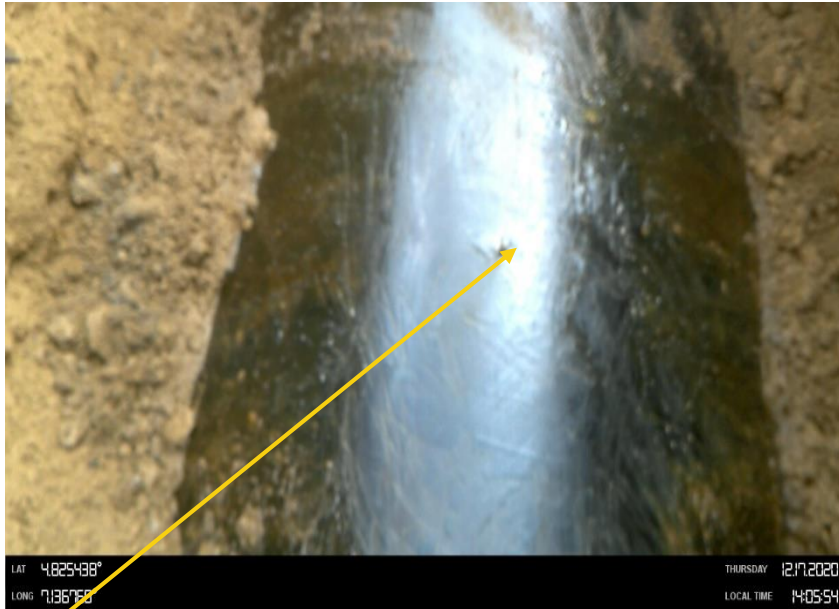
Close-up 4: 4 nos 5mm drilled hole (leak point 3) at 12 o'clock position on 36inch Nkpoku Ogale Pipeline at Agbonchia. Picture was taken during Joint Investigation on 17th Dec 2020.
