JOINT INVESTIGATION REPORT

INCIDENT NO: 2809510 JIV report S/N: 0733

1. Fountain Incident Number: 2809510 2. Type of incident* OIL SPILL
3. Name of Location 36" NKPOKU - OGALE PIPELINE
4. Name of nearest community AGBONCHIA 5. State: RIVERS 6. LGA ELEME
7. Production Facility/Installation CRUDE OIL PIPELINE
8. Asset Owner/Hub THE SHELL PETROLEUM DEVELOPMENT COMPANY
OF NIGERIA LIMITED / PIPELINE

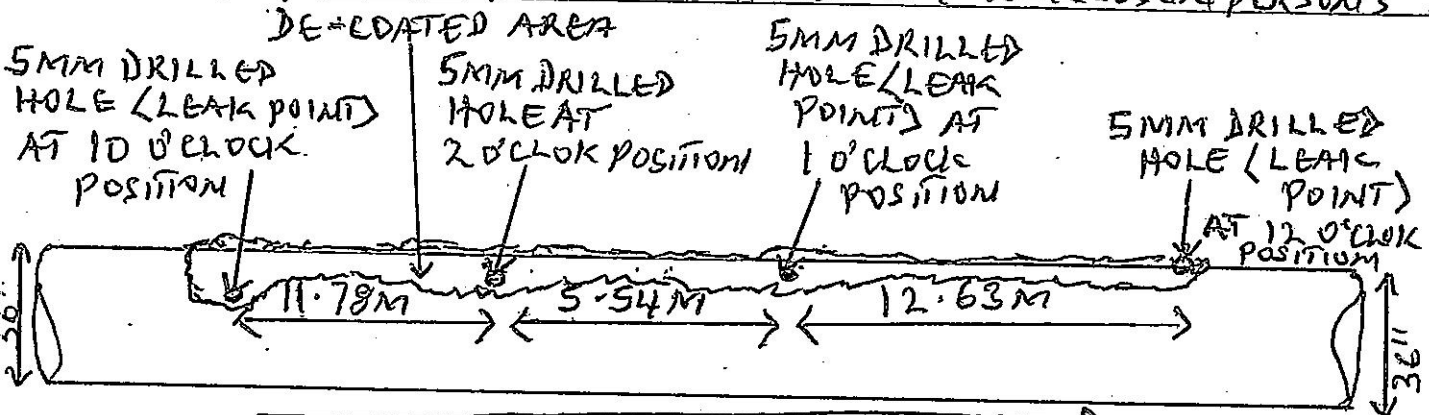
AN EXCAVATION OF ABOUT 37.1 METERS LONG WITH DE-COATED PIPELINE WAS OBSERVED.

| <input checked="" type="checkbox"/> Smooth round-edge hole <u>(DRILLED)</u> | <input type="checkbox"/> Rough-edge hole | <input type="checkbox"/> Hack saw cut |

SECTION OF 36" NIKPOKU - OGALE PIPELINE AT AGBONLITA SHOWING 4 NOS OF DRILLED HOLES BY UNKNOWN PERSONS

FROM NIKPOKU TO OGALE

REPAIR ACTIVITIES ARE ONGOING.
