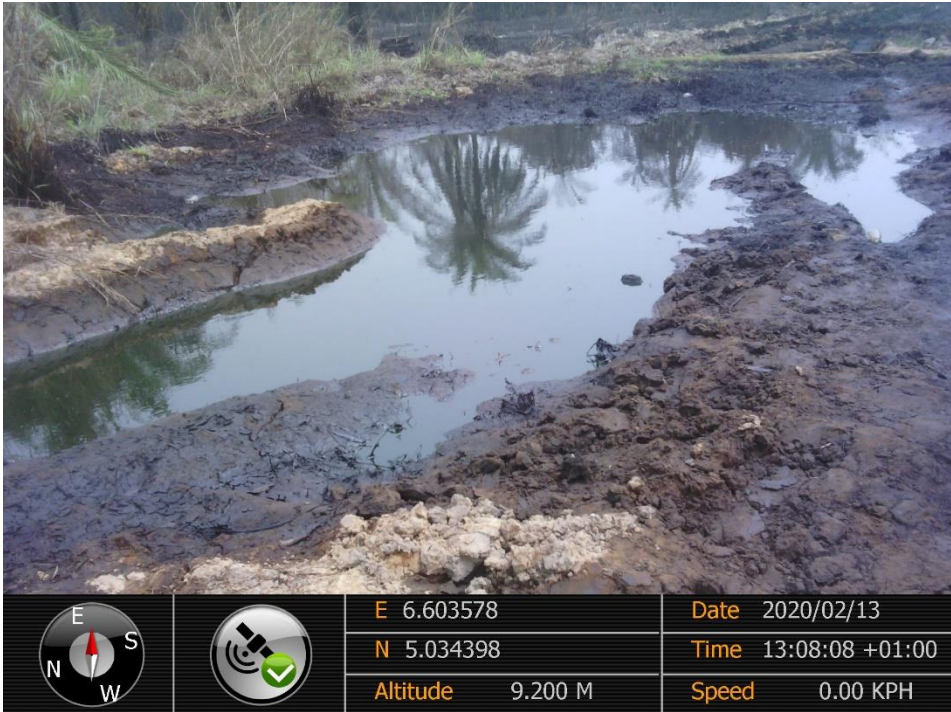
Overview: Part of spill impact on 14" Okordia - Rumuekpe Pipeline at Ikata. Picture was taken during Joint Investigation of 13th February 2020.

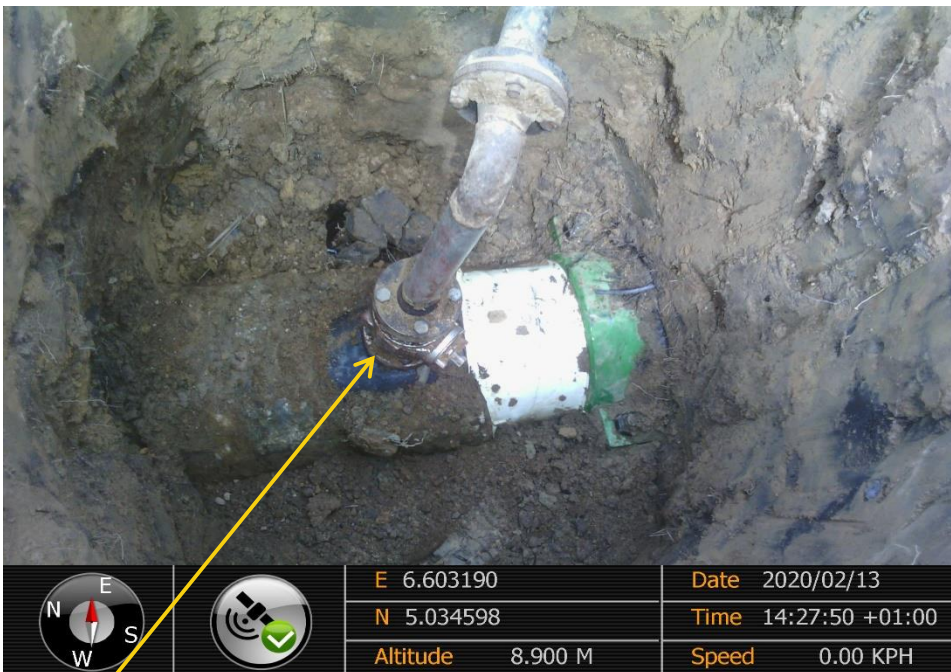
Close-up: Crude oil theft point installed at 12 o'clock position on 14" Okordia - Rumuekpe Pipeline at Ikata. Picture was taken during Joint Investigation of 13th February 2020.
