# JOINT INVESTIGATION REPORT

INCIDENT NO: 2587546 JIV report S/N:

1. Fountain Incident Number: 2587546 2. Type of incident\* OIL SPILL  
3. Name of Location 4" IMO RIVER WELL 43T FLOW LINE  
4. Name of nearest community IGIRIUKWU 5. State: ABIA 6. LGA UKWA WEST  
7. Production Facility/Installation CRUDE OIL FLOW LINE  
8. Asset Owner/Hub THE SHELL PETROLEUM DEVELOPMENT COMPANY OF NIGERIA LIMITED (SPDC) LAND EAST HUB

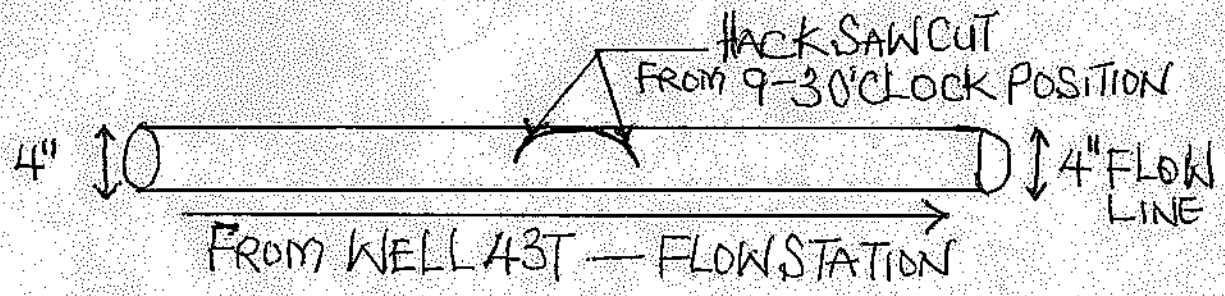
**E. GRAPHIC DESCRIPTION OF LEAK POINT** (while detailed description of the leak point should be contained in the leak report, overview sketch of the site should be added as appendix)

A RAG TIED AROUND THE PIPE CLOSE TO THE HACK SAW POINT.

| <input type="checkbox"/> Smooth round-edge hole | <input type="checkbox"/> Rough-edge hole | <input checked="" type="checkbox"/> Hack saw cut |

A SECTION OF 4" INDI RIVER WELL 43T FLOWLINE AT IGRIUKWU-OWAZA SHOWING A HACK SAW CUT FROM 9 O'CLOCK - 3 O'CLOCK POSITION BY UNKNOWN PERSON.
