**Overview:** Part of spill impact on 14" Okordia Rumuekpe Pipeline at Akalamini. Picture was taken during Joint Investigation of 25<sup>th</sup> February 2020.

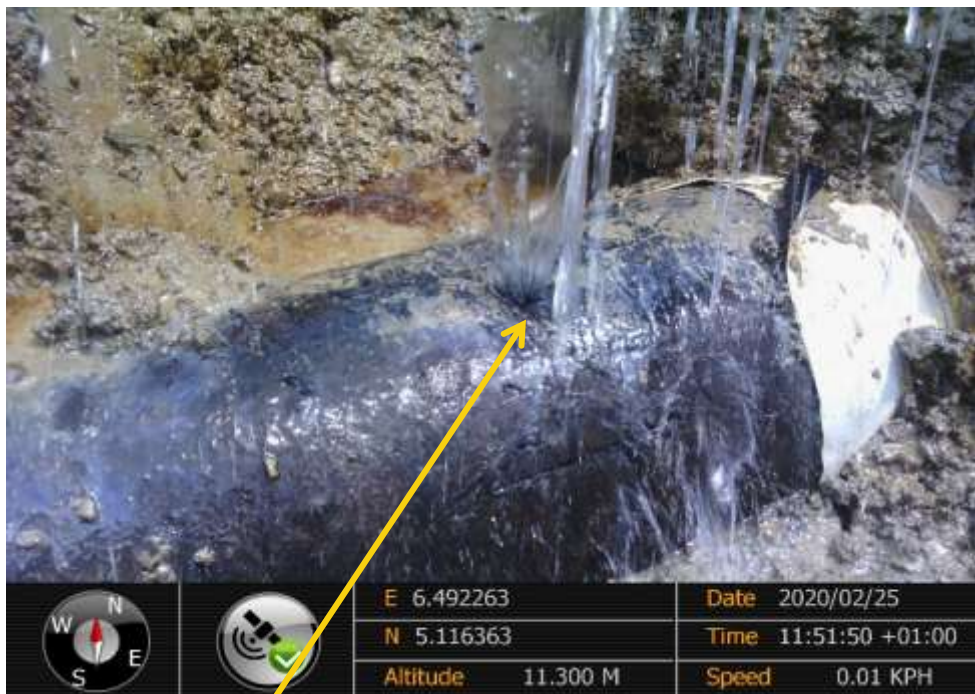
**Close-up:** Point 1 drilled hole at 12 o'clock position showing water and oil on 14" Okordia Rumuekpe Pipeline at Akalamini. Picture was taken during Joint Investigation of 25<sup>th</sup> February 2020.

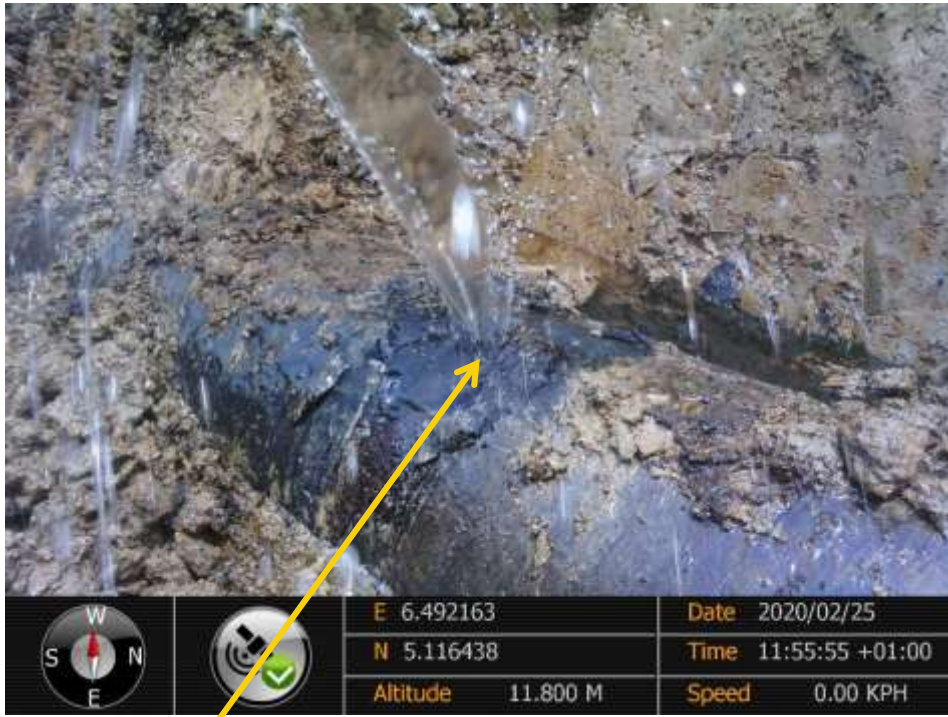
Close-up: Point 2 drilled hole at 12 o'clock position on 14" Okordia Rumuekpe Pipeline showing water and oil at Akalamini. Picture was taken during Joint Investigation of 25<sup>th</sup> February 2020.

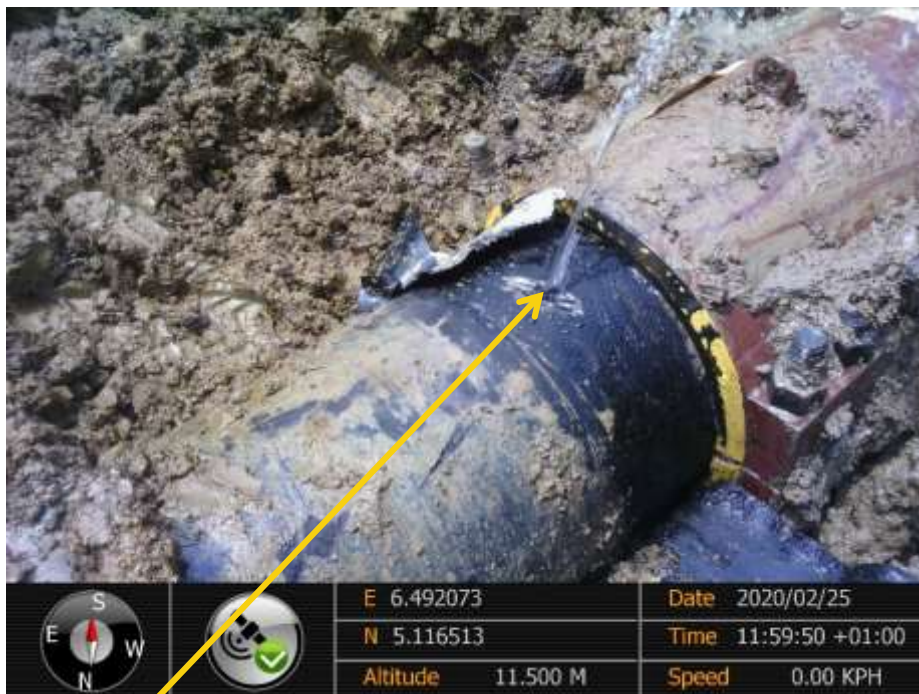
Close-up: Point 3 drilled hole at 12 o'clock position on 14" Okordia Rumuekpe Pipeline showing water and oil at Akalamini. Picture was taken during Joint Investigation of 25<sup>th</sup> February 2020.

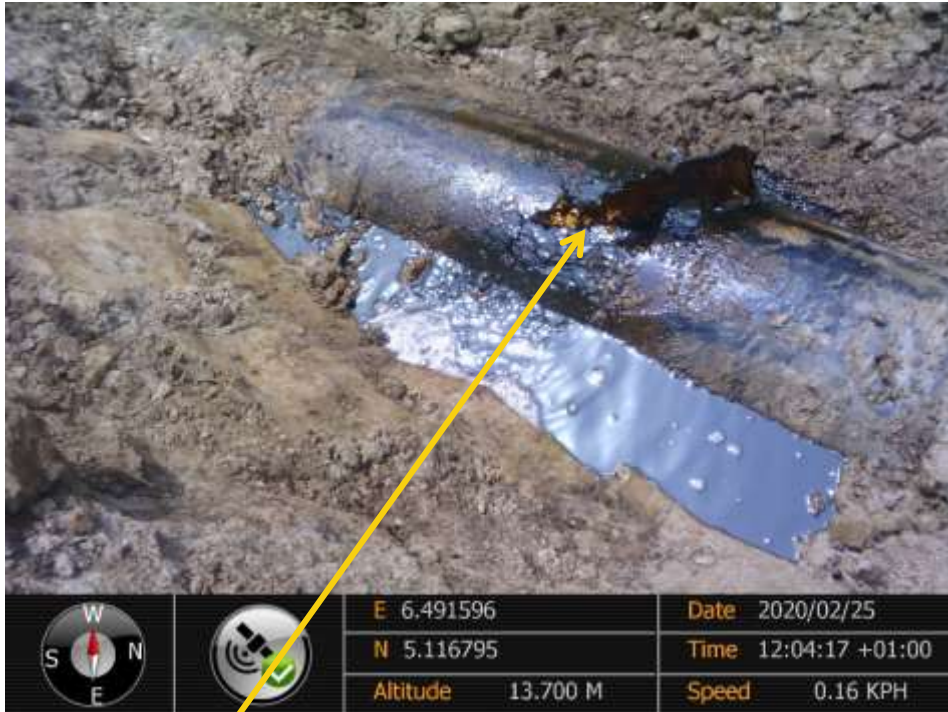
Closeup: Point 4 drilled hole at 12 o'clock position on 14" Okordia Rumuekpe Pipeline at Akalamini. Picture was taken during Joint Investigation of 25<sup>th</sup> February 2020.

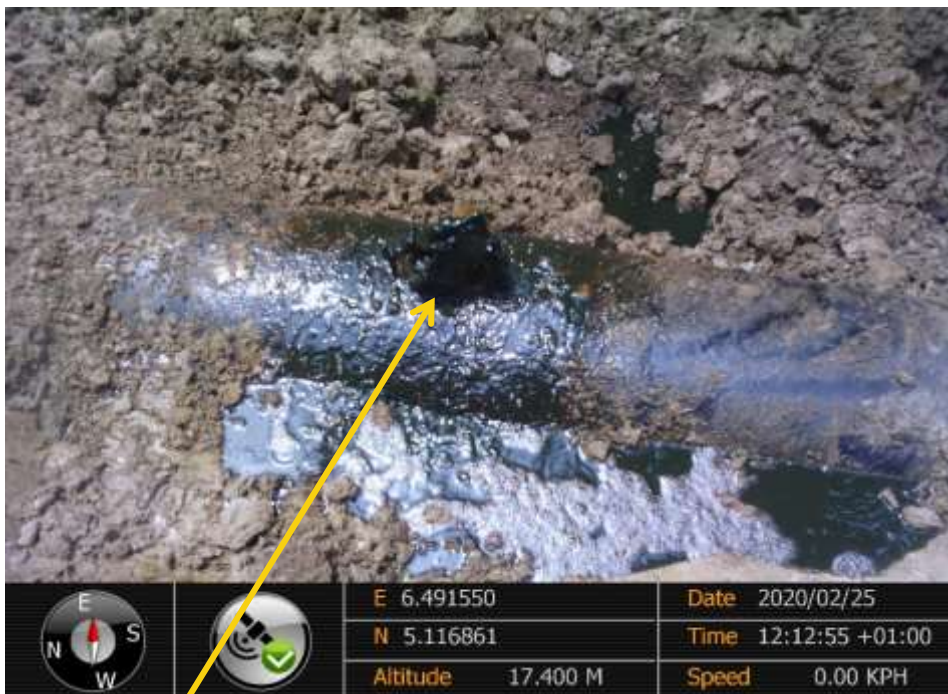
Close-up: Point 5 drilled hole at 12 o'clock position on 14" Okordia Rumuekpe Pipeline at Akalamini. Picture was taken during Joint Investigation of 25<sup>th</sup> February 2020.
