JOINT INVESTIGATION REPORT

INCIDENT NO: 2584501 JIV report S/N:

1. Fountain Incident Number: 2584501 2. Type of incident* OIL SPILL
3. Name of Location 14" OKORDIA - RUMUEKPE PIPELINE
4. Name of nearest community AKALAMINI 5. State: RIVERS 6. LGA AHOADA - WEST
7. Production Facility/Installation: OIL PIPELINE
8. Asset Owner/Hub THE SHELL PETROLEUM DEVELOPMENT COMPANY
OF NIGERIA LIMITED / PIPELINE

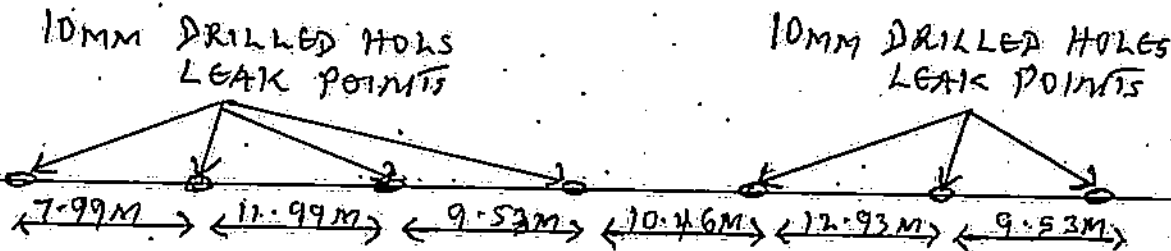
E. GRAPHIC DESCRIPTION OF LEAK POINT (while detailed description of the leak point should be contained in the leak report, overview sketch of the site should be added as appendix 1)

Additional observations around the spill point: 7 NUMBER DRILLED HOLES WERE OBSERVED WITHIN 100-METER LENGTH ON THE 14" OKORDIA - RUMUEKPE PIPELINE. EACH OF THE DRILLED HOLES WAS 10MM DIAMETER AND ALL AT 12 O'CLOCK POSITIONS.

SECTION OF 14" OKORDIA - RUMUEKPE PIPELINE AT AKALAMINI SHOWING 7 NOS OF DRILLED HOLES AT 12 O'CLOCK POSITION BY UNKNOWN PERSON(S)

FROM OKORDIA TO RUMUEKPE →

REPAIR WORK ONGOING

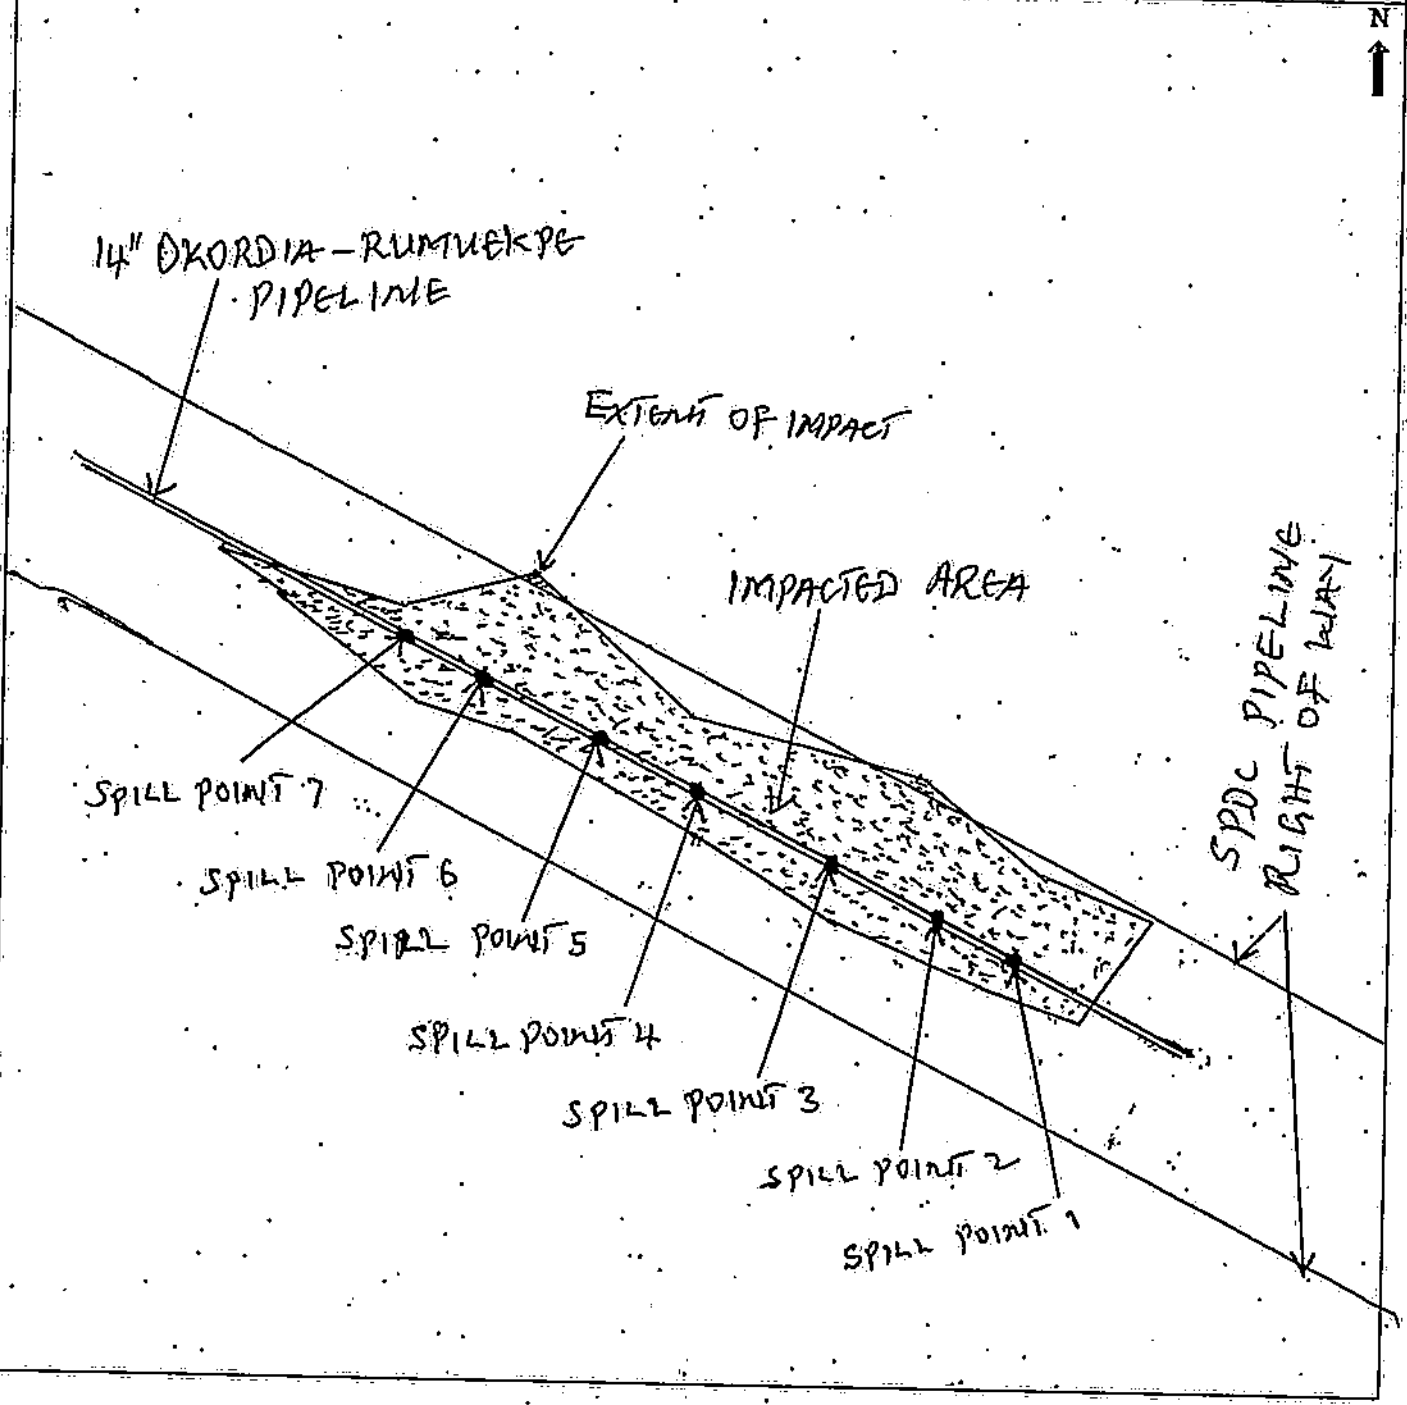
f. Appendix 1: Overview sketch of the site

Location: 14" OKORDIA - RUMUEKPE PIPELINE AT AKALAMINI
