JOINT INVESTIGATION REPORT

INCIDENT NO: 2584510 JIV report S/N: 0456

1. Fountain Incident Number: 2584510 2. Type of incident* OIL SPILL
3. Name of Location 14" OKORDIA - RUMUKECE PIPELINE
4. Name of nearest community AKALAMINI 5. State: RIVERS 6. LGA AHOADA WEST
7. Production Facility/Installation OIL PIPELINE
8. Asset Owner/Hub THE SHELL PETROLEUM DEVELOPMENT COMPANY OF NIGERIA LIMITED / PIPELINE

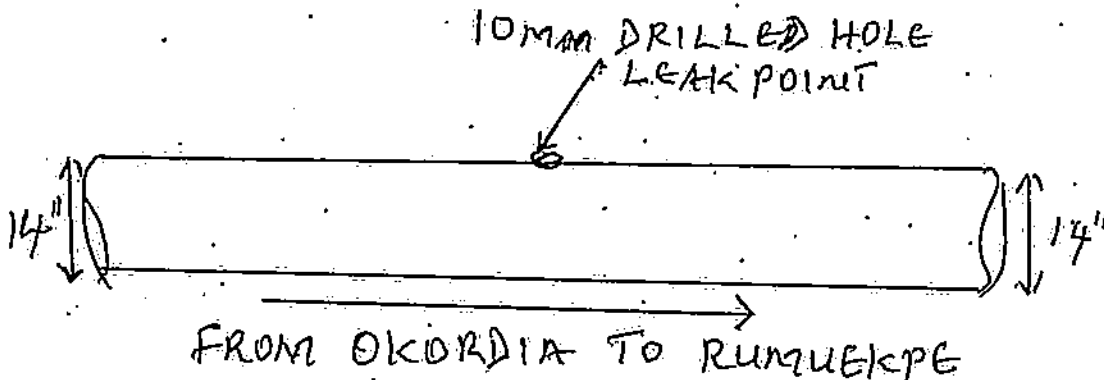
E. GRAPHIC DESCRIPTION OF LEAK POINT (while detailed description of the leak point should be contained in the leak report, overview sketch of the site should be added as appendix 1).

| <input checked="" type="checkbox"/> Smooth round-edge hole | <input type="checkbox"/> Rough-edge hole | <input type="checkbox"/> Hack saw cut |

SECTION OF 14" OKORDIA - RUMUEKPE PIPELINE AT AKALANGINI SHOWING DRILLED HOLE BY UNKNOWN PERSON(S) AT 12 O'CLOCK POSITION

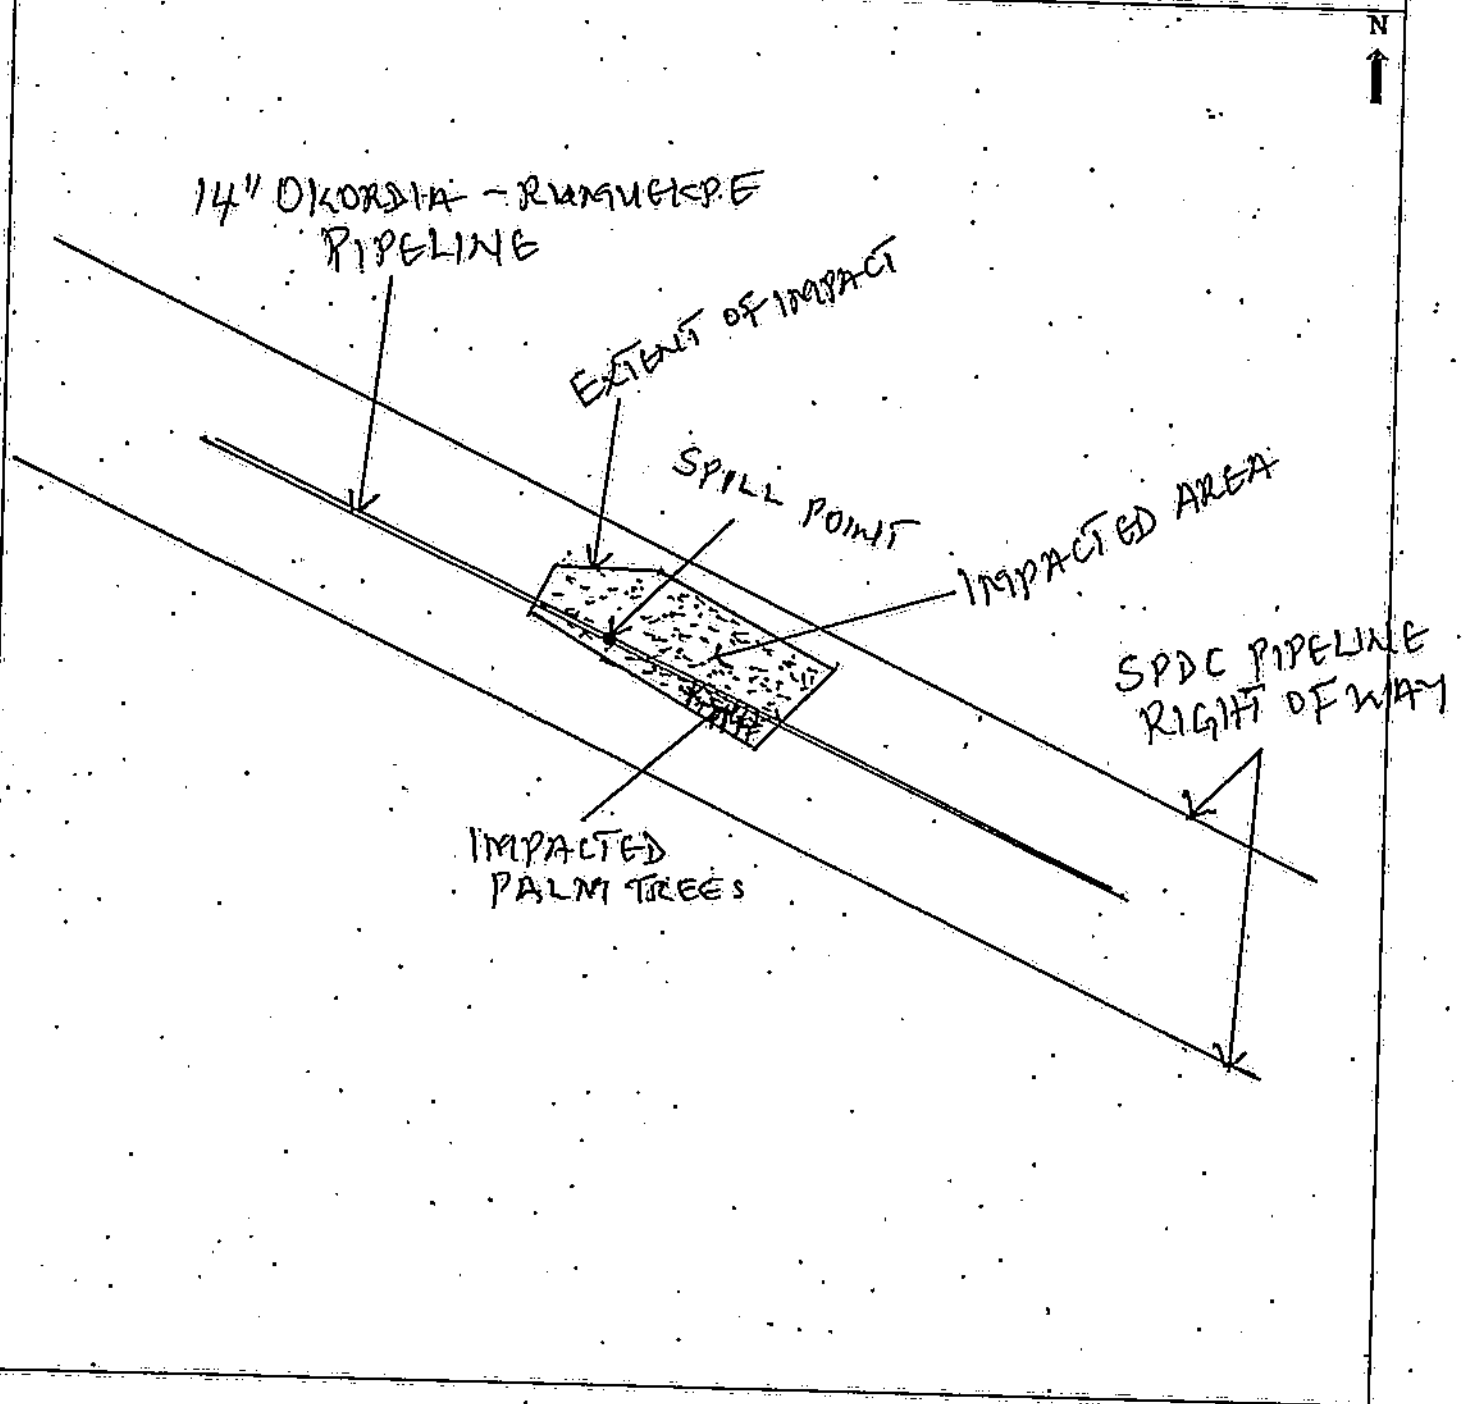
f. Appendix 1: Overview sketch of the site

Location: 14" OKORDIA - RUMUKEPE PIPELINE AT AKALAMINI
