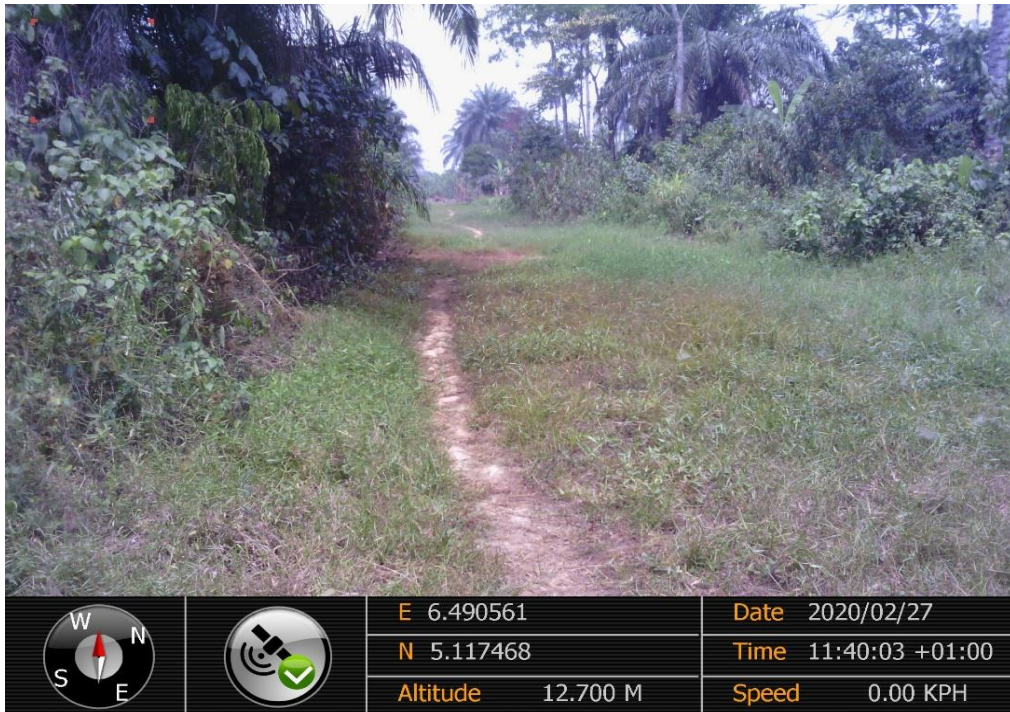
Overview: Part of spill impact on 14" Okordia Rumuekpe Pipeline at Akalamini. Picture was taken during Joint Investigation of 27th February 2020.

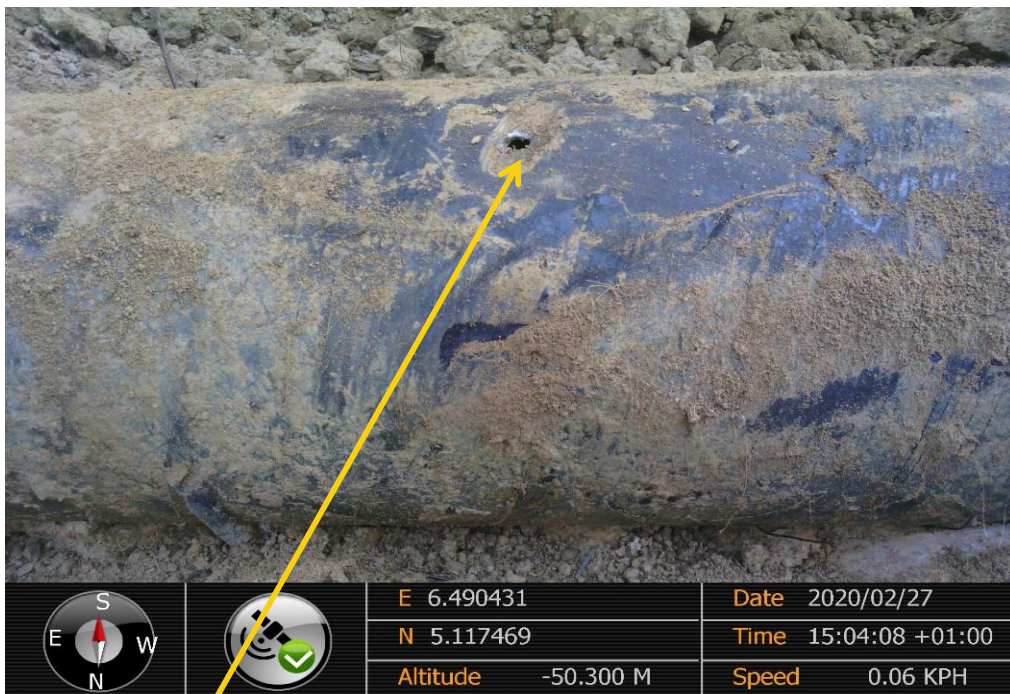
Close-up: 10mm Drilled hole on 14" Okordia Rumuekpe Pipeline at Akalamini. Picture was taken during Joint Investigation of 27th February 2020.
